INSPECTION REPORT

HIDDEN LAKE DAM CT DEEP #06107

HIDDEN LAKE ROAD
TRIBUTARY TO POND MEADOW BROOK
HADDAM, CONNECTICUT

MARCH 2015

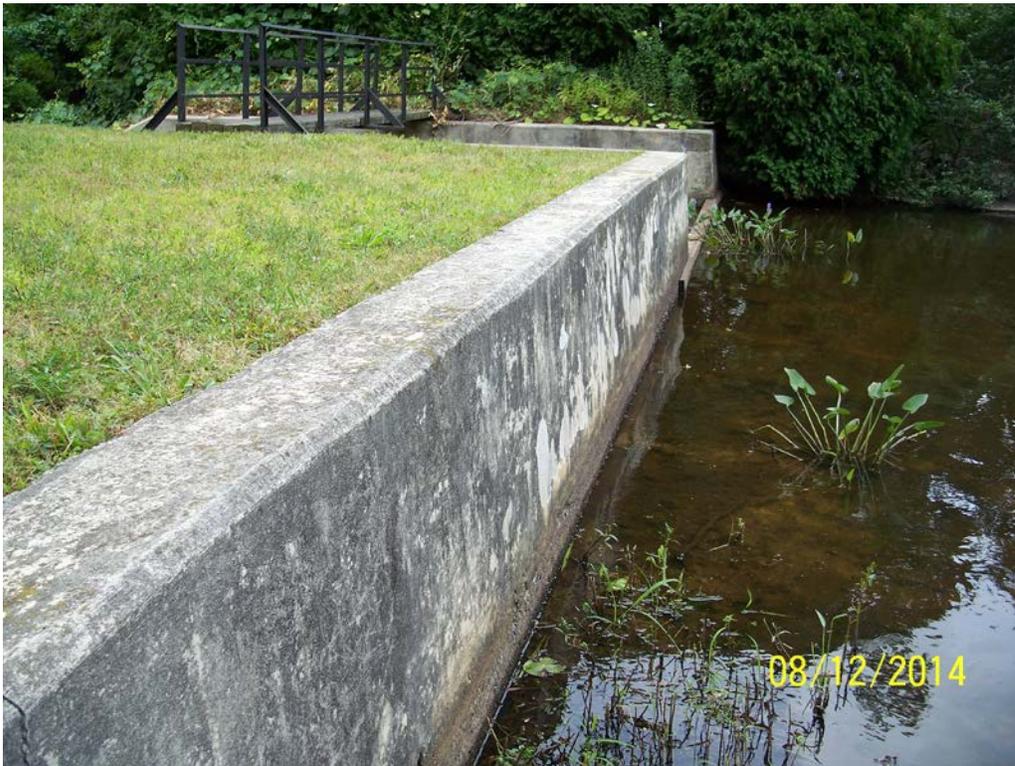
Photo 1a – An overview of the dam taken from the left (east) abutment. The spillway is at the upper center of the photo; the spillway bridge is visible at the top left center.

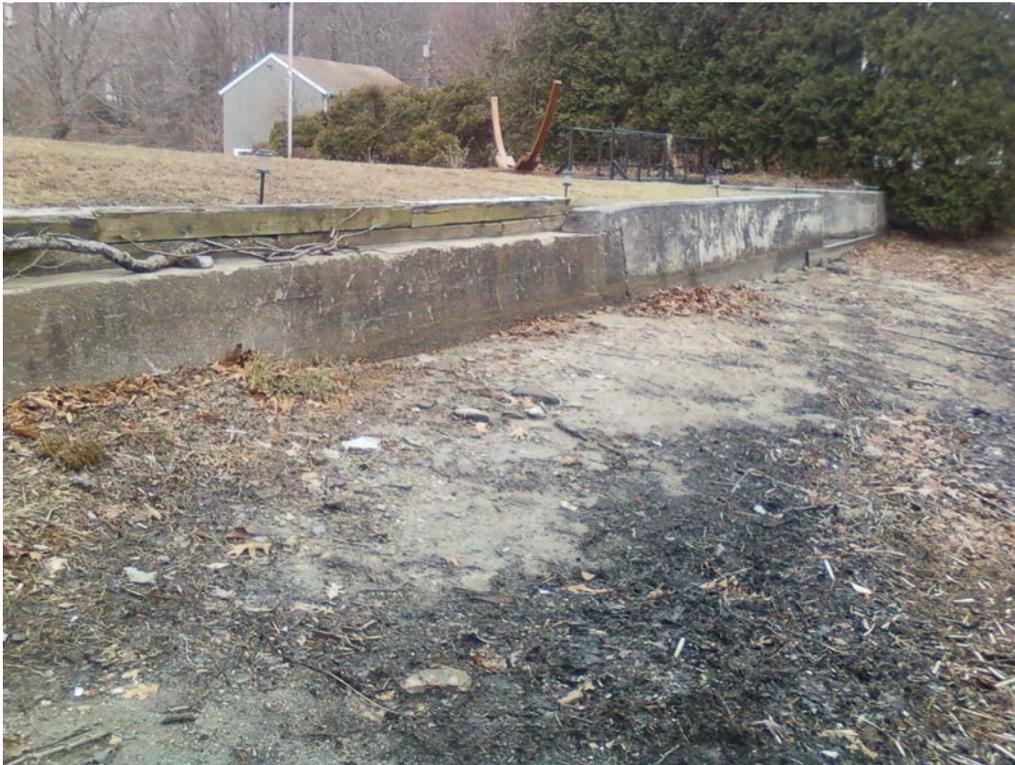
Photo 1b – Another upstream view, again taken from the left abutment area, but at a later date subsequent to annual fall drawdown. [12-18-2014]

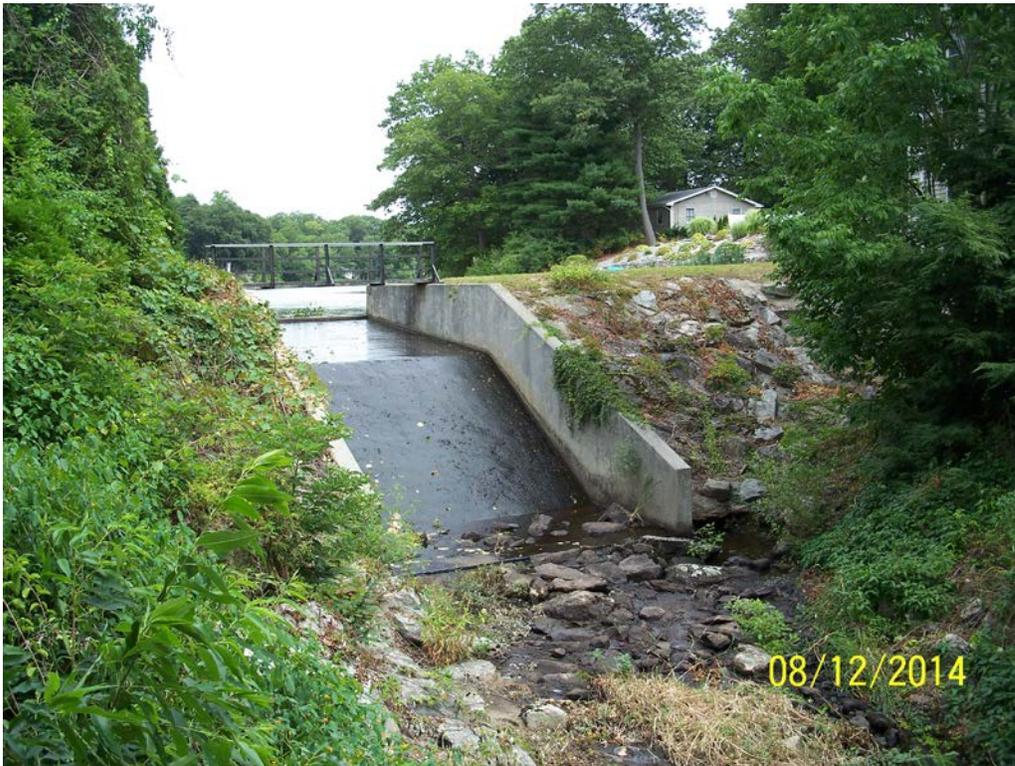
Photo 2 – Overview of the dam from the right downstream channel embankment looking toward the spillway and left embankment area. Because of the heavy vegetative cover, a more encompassing overview was impractical.

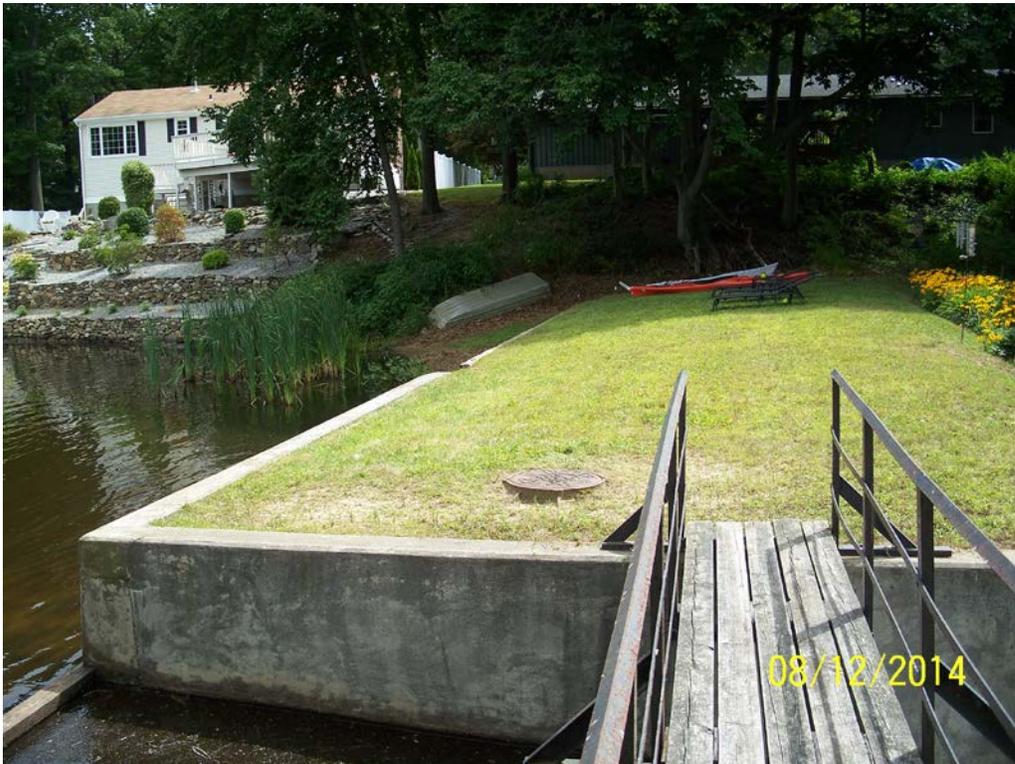
Photo 3 – Although an upstream view of the dam from the right abutment was not available due to heavy vegetative cover, this view gives some idea of the appearance (see also Photos 1a and 1b from the left abutment area).

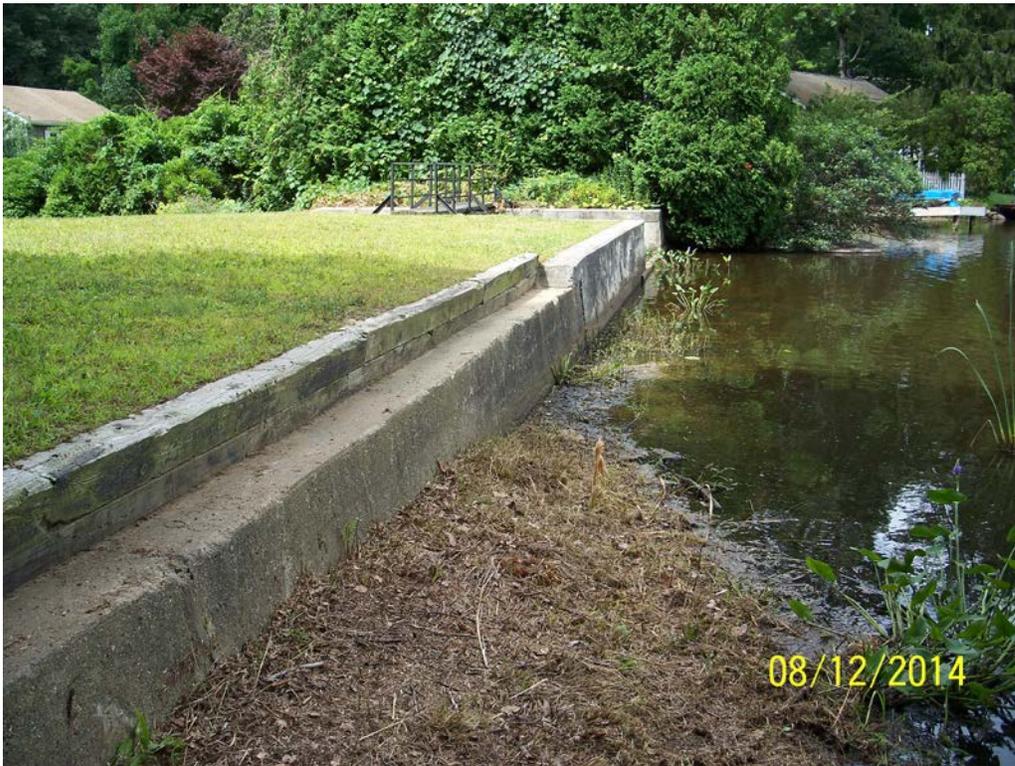
Photo 4 – A view of the upstream face from the left abutment. Note the spillway is in the upper center of the photo and that the right abutment is covered in trees and brush.

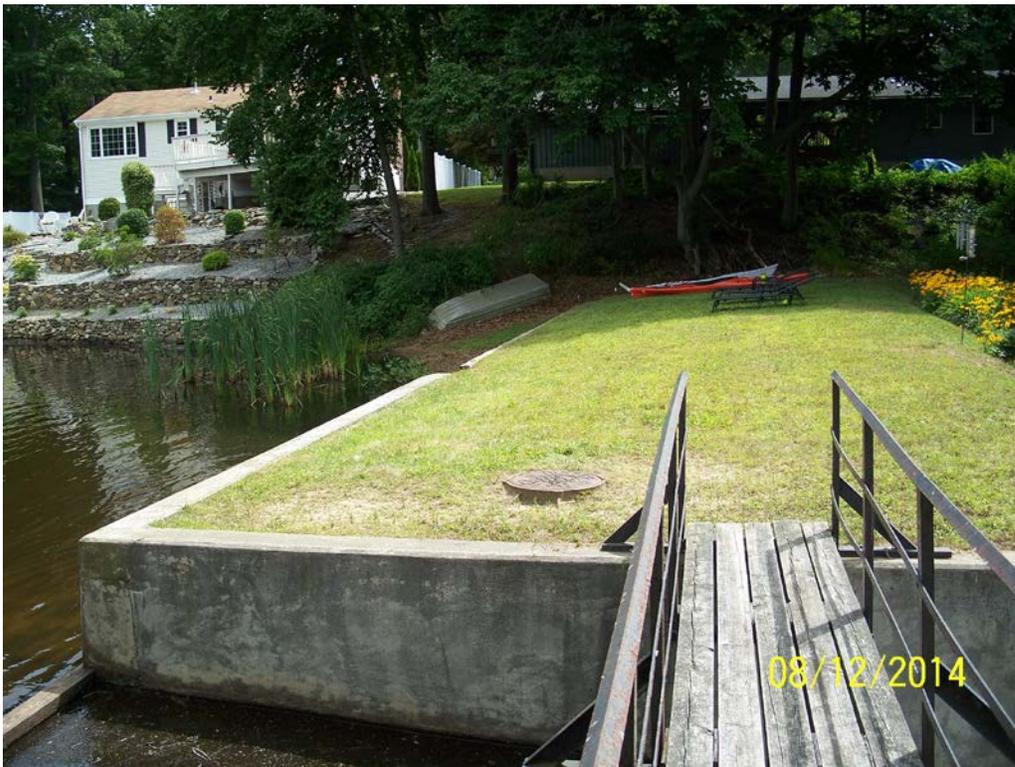
Photo 5a – An overview of the dam crest from the right abutment looking towards the left. The spillway footbridge crossing is in the foreground, and a manhole cover just to the left of the bridge and past the spillway training wall is the outlet valve control chamber.

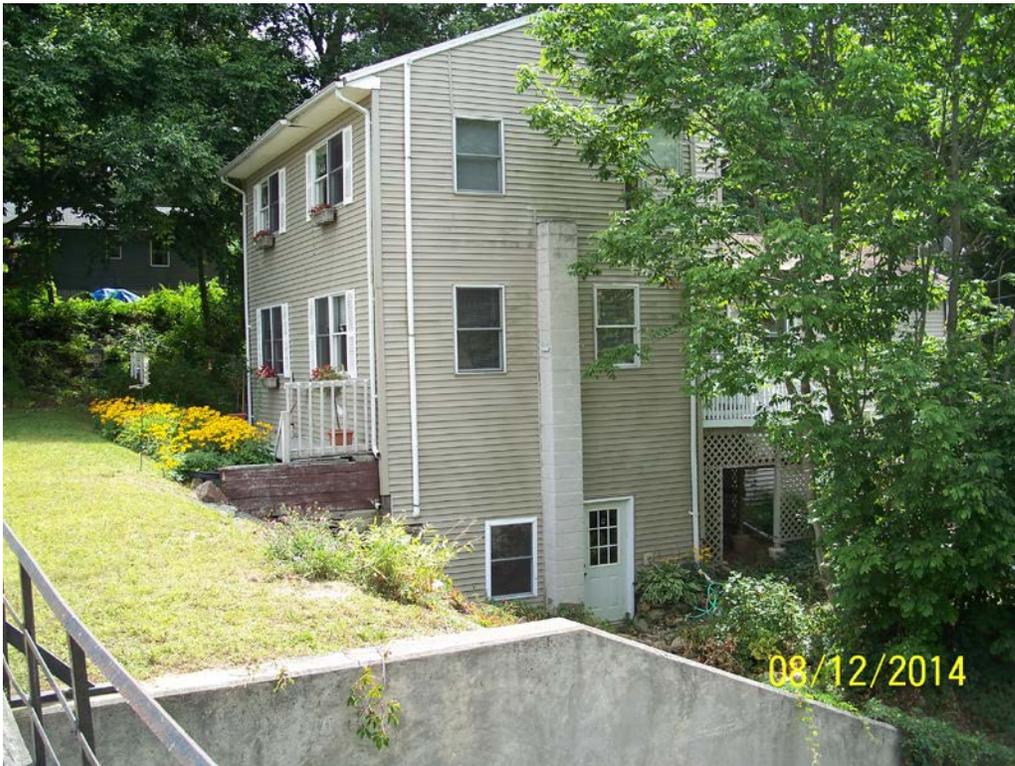
Photo 5b – Another overview of the dam from the right abutment showing the relationship of the downstream house to the dam embankment.

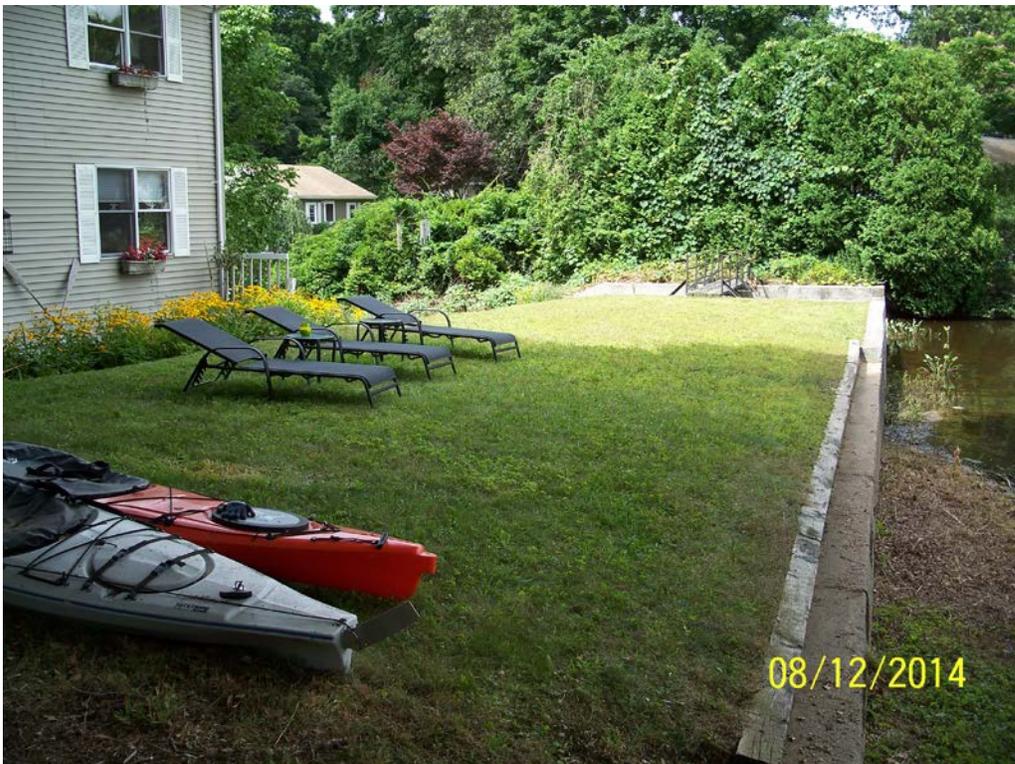
Photo 6 – An overview of the dam crest from the left abutment area. Again, note the house location with respect to the left embankment.

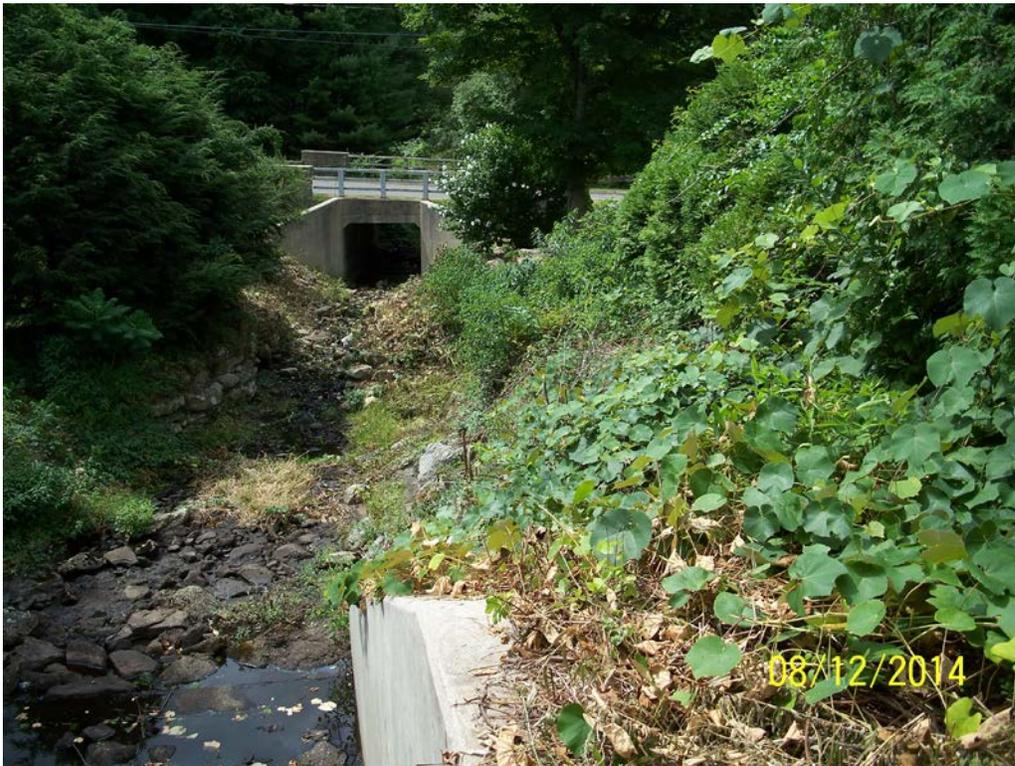
Photo 7a – The downstream face as seen from atop the right abutment area. The spillway is at the left bottom of the photo. Note the extensive vegetative growth along the right abutment and right downstream slope.

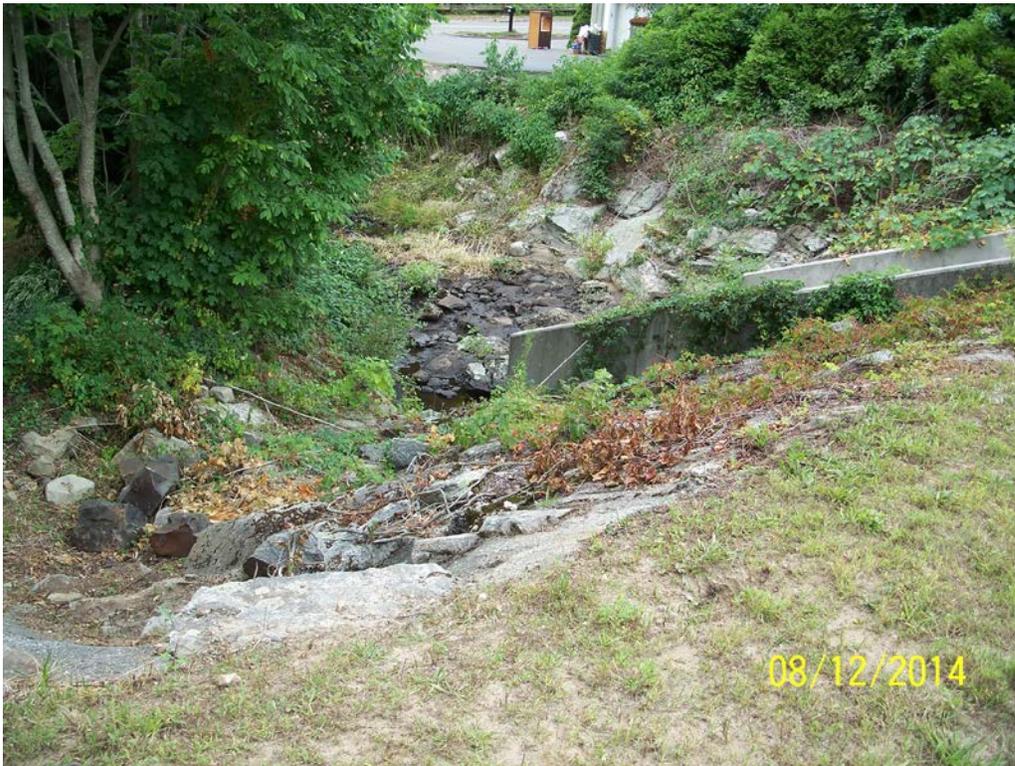
Photo 8a – The downstream face of the embankment to the left of the spillway as seen from the top of the dam, adjacent to the house (to the left of the photo – see Photo 8c). Note heavy vegetative growth along the toe and right embankment areas, as well as small brush growth within the downstream riprap slope.

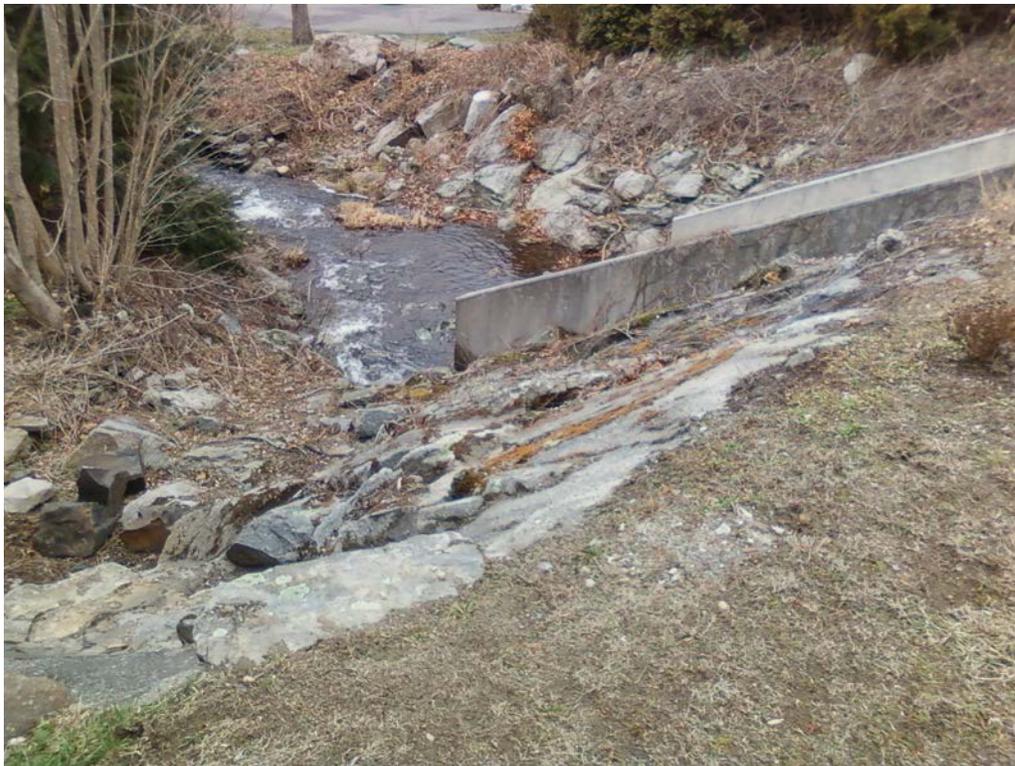
Photo 8b – The same view as Photo 8a above, but taken at a later date, 12/22/2014.

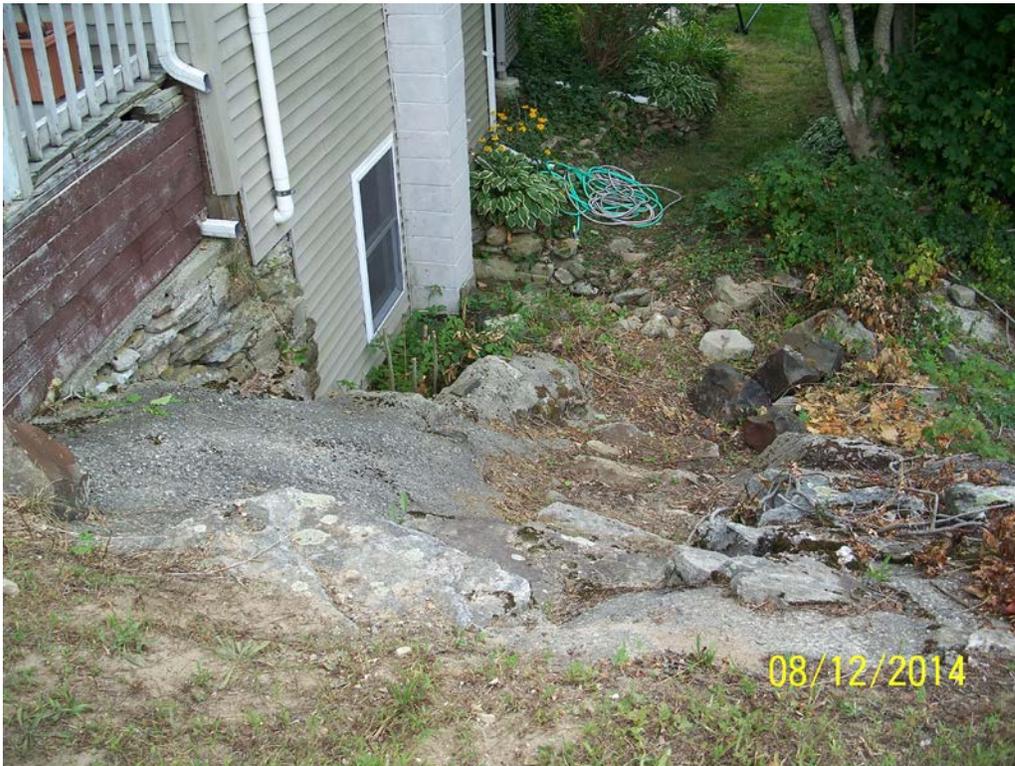
Photo 8c – Another view of the downstream slope to the left of the spillway, taken from atop the left embankment crest. (See also Photos 6 and 7b for views of the house situated on the left downstream embankment.)

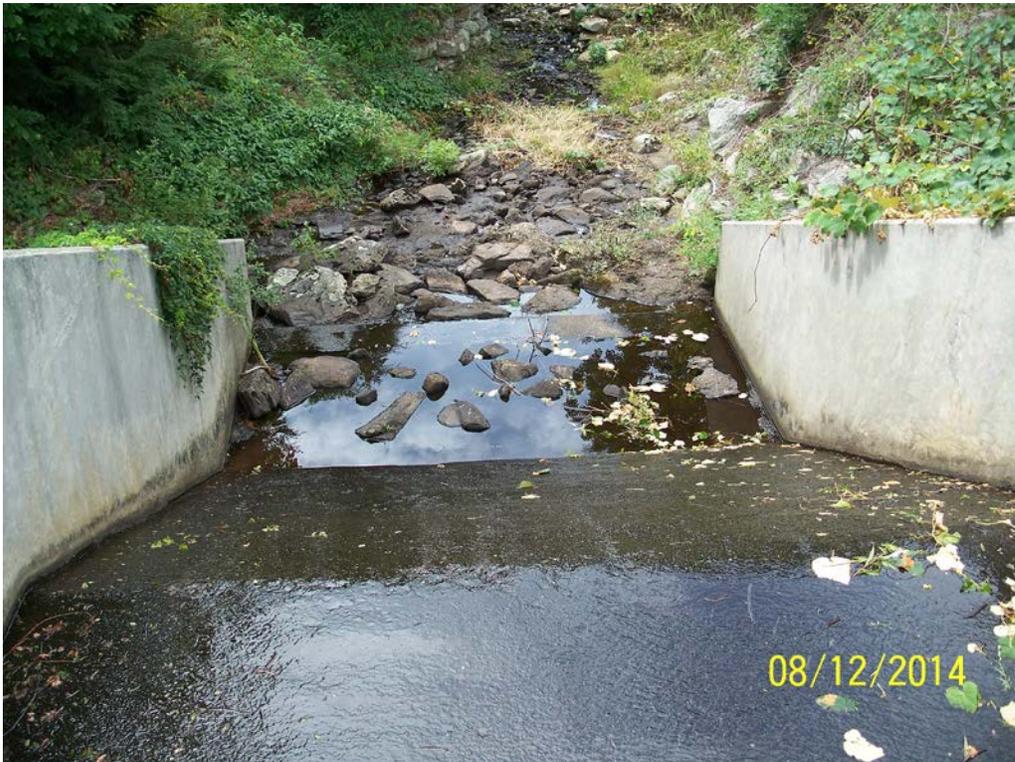
Photo 9 – The spillway looking in a downstream direction from atop the spillway footbridge on the upstream end.

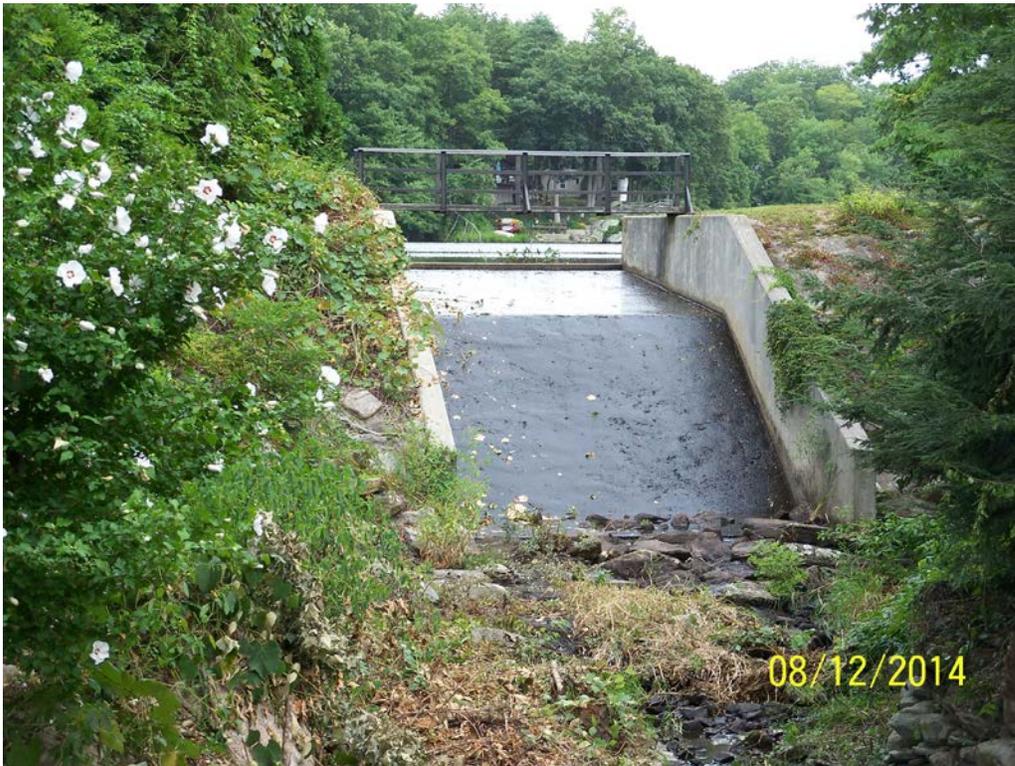
Photo 10a – The spillway as seen from the downstream channel. Note tree and brush cover along both sides.

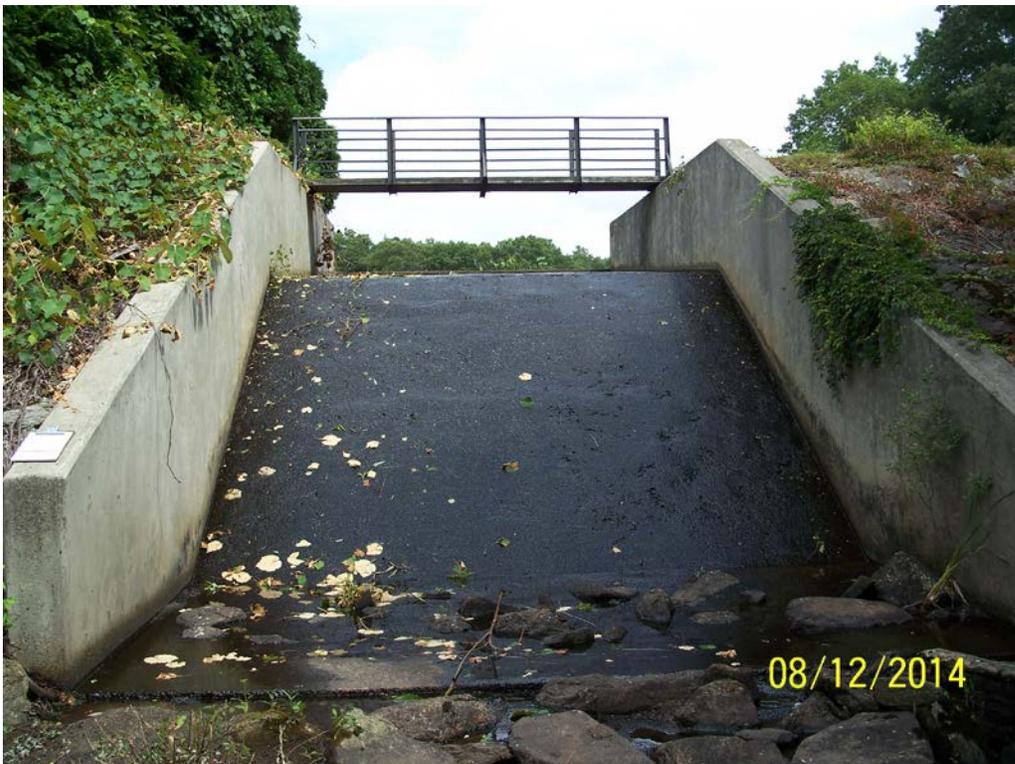
Photo 10b – Another view of the spillway from downstream with particular emphasis on the cover along the right spillway embankment slope area.

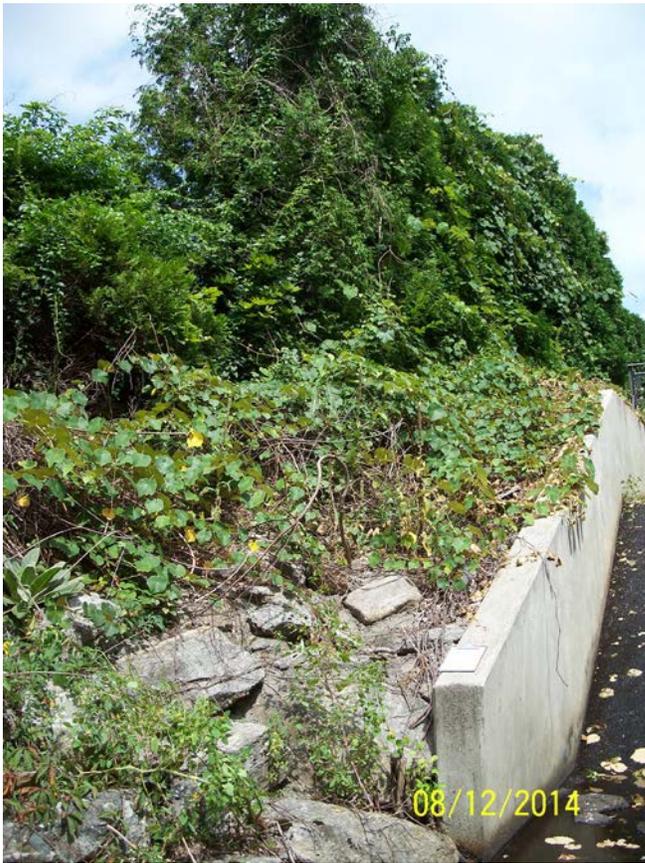
Photo 11a – Overview of the right training wall with dense brush and arbor vitae growth.

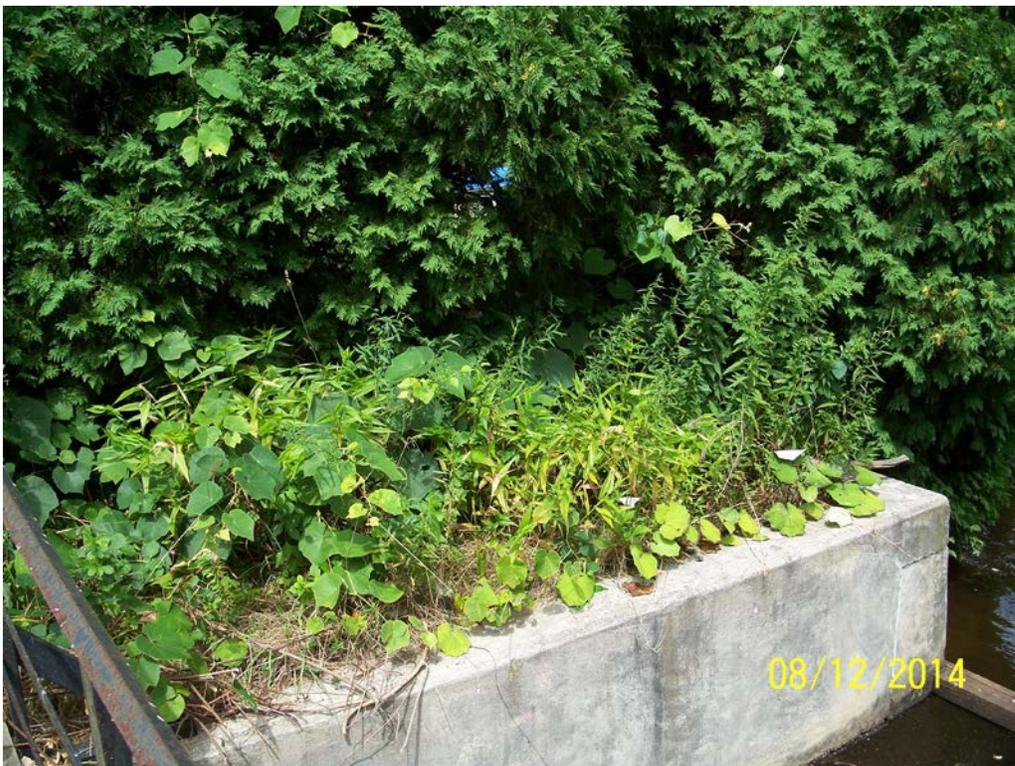
Photo 11b – A close-up of the upstream end of the right spillway training wall.

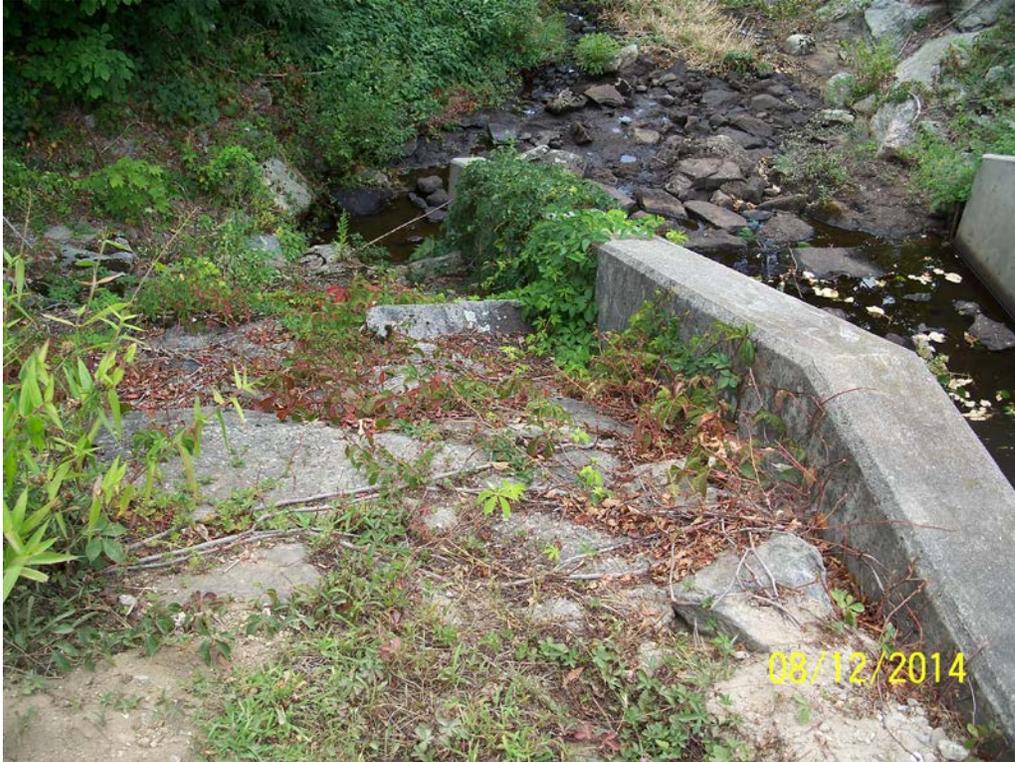
Photo 12a – An overview of the left spillway training wall; this wall is in generally good condition.

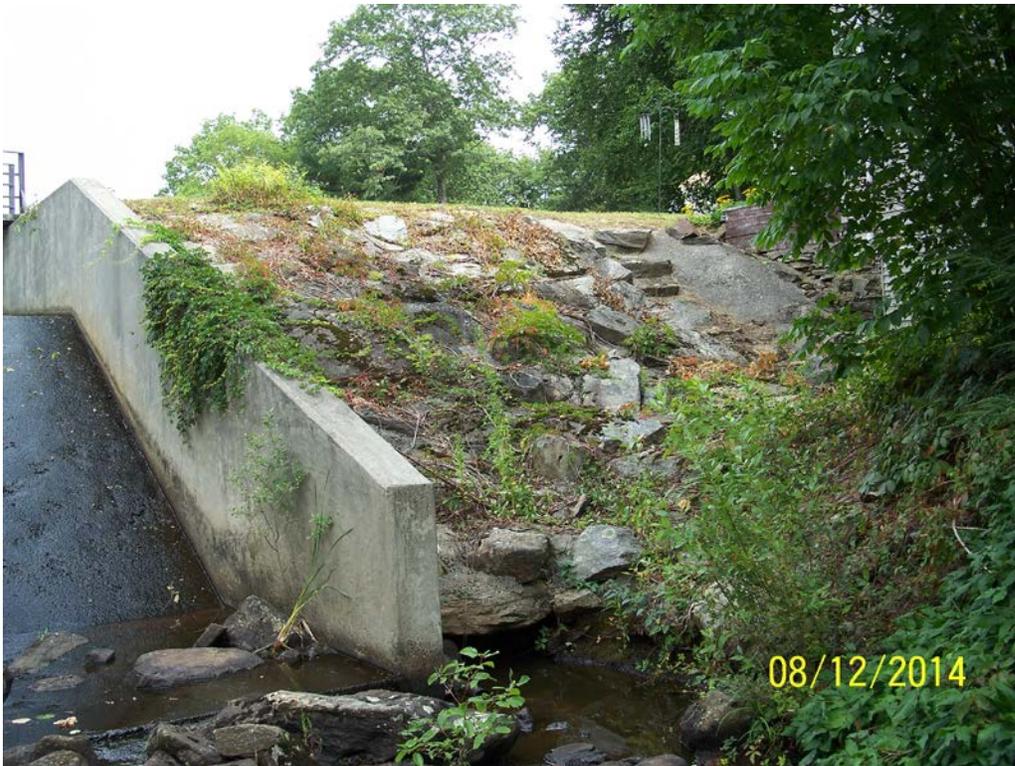
Photo 12b – Another view of the left spillway training wall from the center of the downstream channel. (See also Photo 5a for a view of the left training wall at the footbridge crossing).

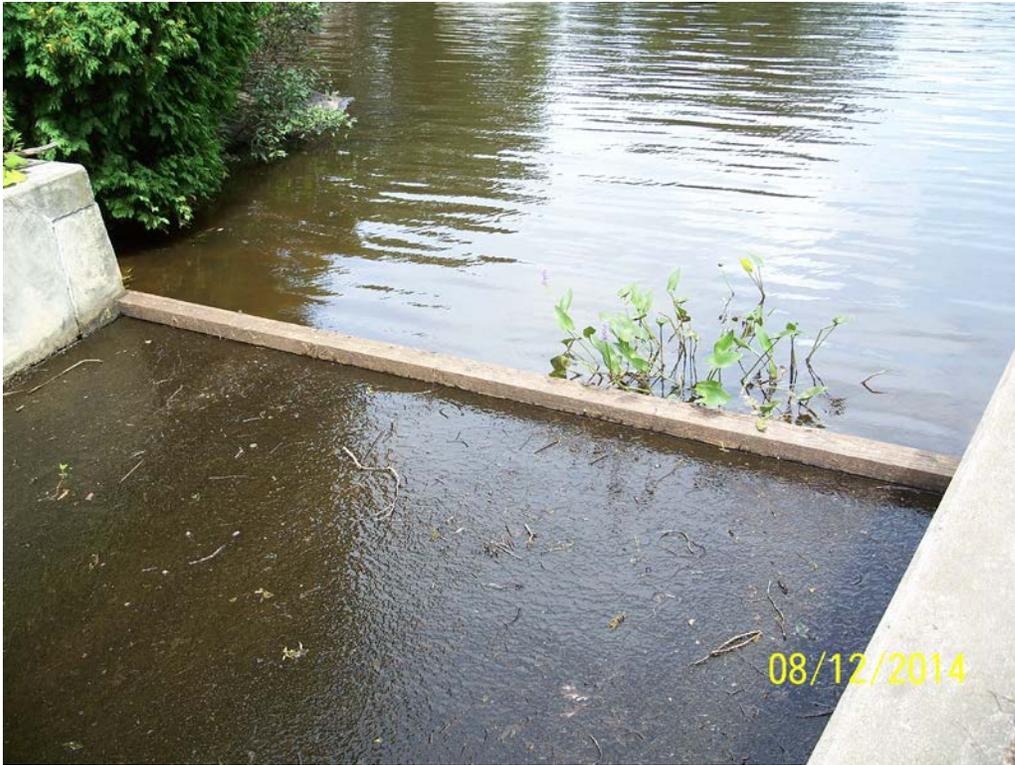
Photo 13 – An overview of the spillway weir, as seen from the left training wall looking upstream.

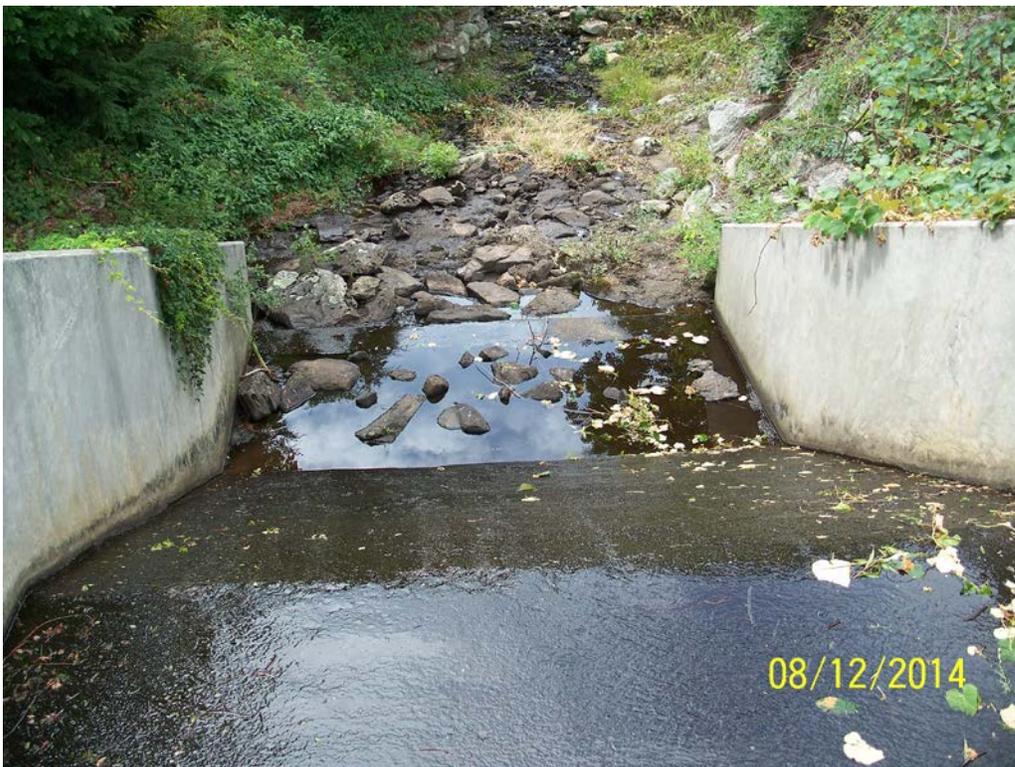
Riprap: At the base of the spillway, riprap was in good condition with no apparent displacement of stone.

Photo 14 – The stilling basin at the lower end of the sloped spillway discharge channel. The riprap at the base was in stable condition.

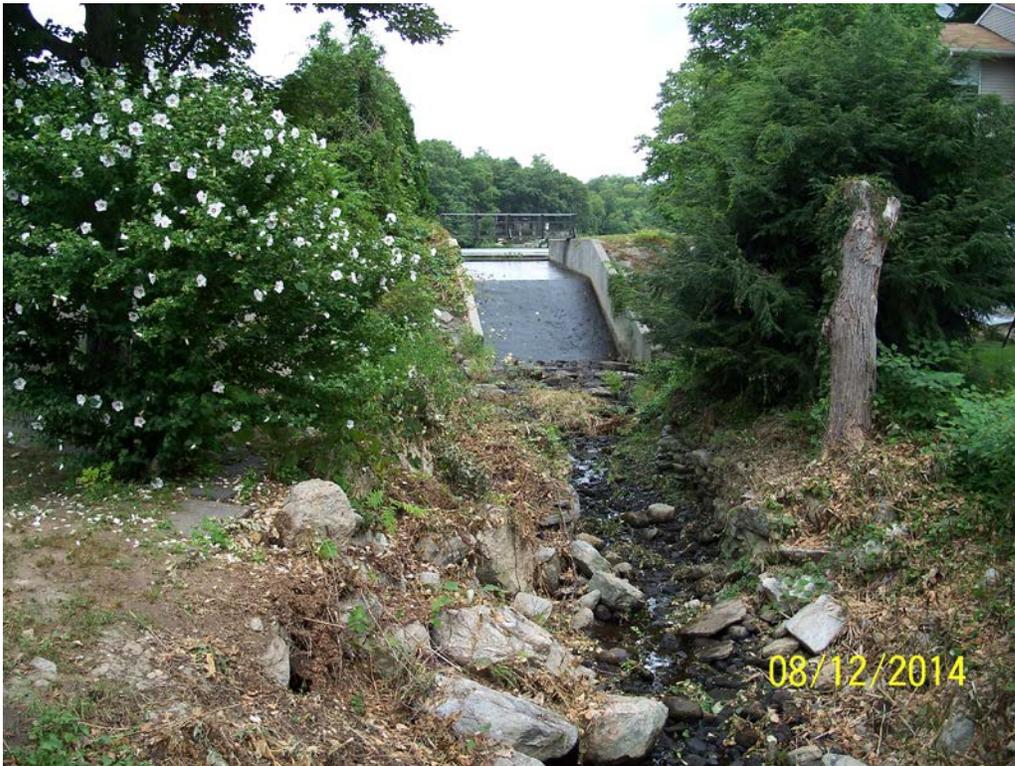
Photo 15a – An overview of the downstream channel, as seen from the entrance area to the road culvert.

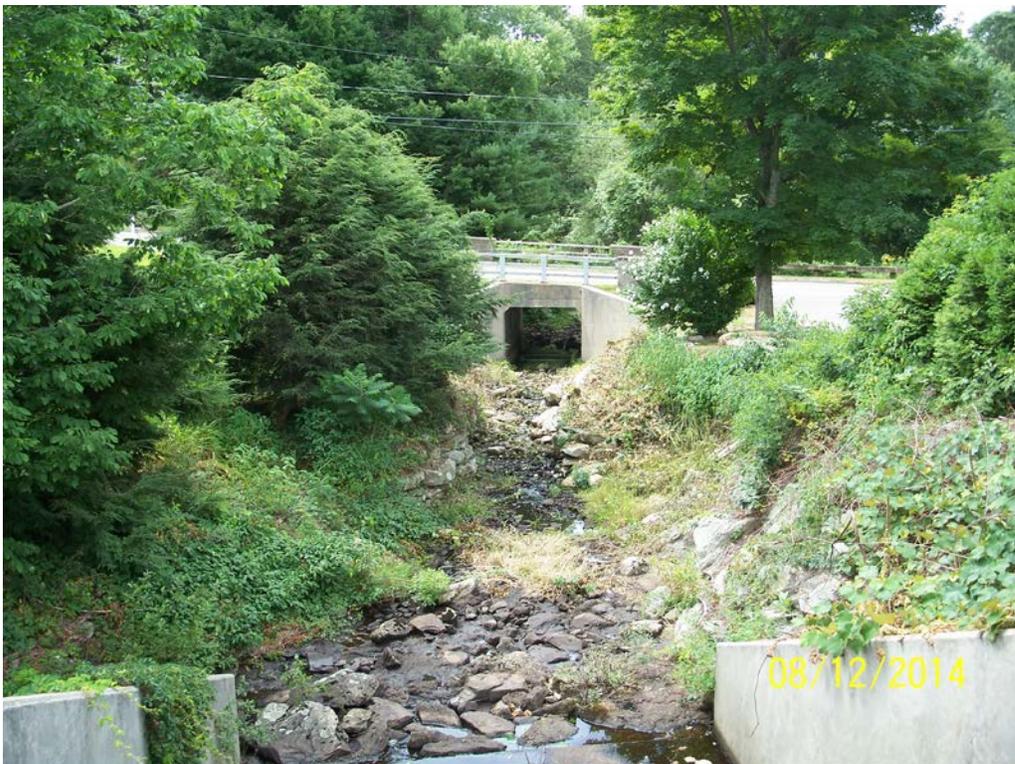
General Condition: Base of channel is in good condition; side slopes were heavily vegetated at the time of the first inspection, particularly in the vicinity of the dam and spillway, but cleared for the second inspection. Heavy growth could impede flow and decrease the hydraulic efficiency during high outflow conditions.

Photo 15b – An overview of the downstream channel as seen from the top of the spillway looking toward the road culvert. Note dense vegetative growth along the channel slopes.

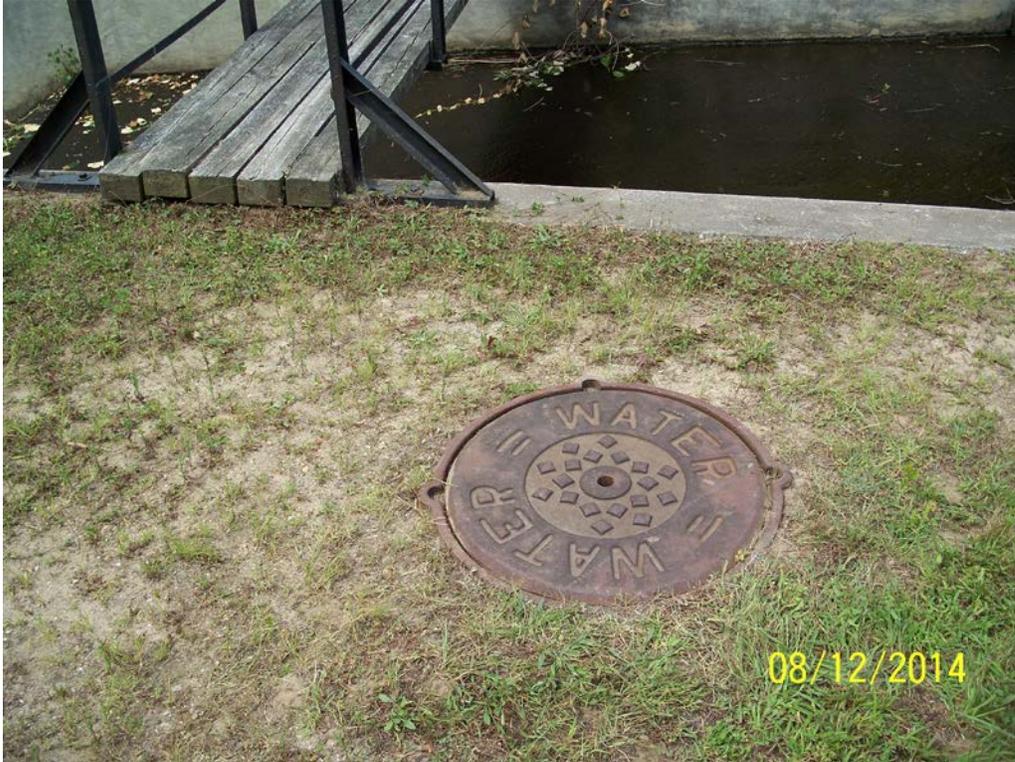
General Condition: The structure is in generally satisfactory condition, the gate valve is fully operable, but the manhole is consistently flooded and the gate valve submerged. See Recommendations.

Photo 16 – The exterior of the valve chamber for the low level outlet pipe.

5. **Valve Chamber** - Concern was expressed about the exterior condition of the valve body and the water within the valve chamber (manhole). Some slow leakage is expected for this type of concrete structure, as is the corrosion on the valve itself. Unless maintained and operated on a consistent basis, slow deterioration will occur. It is recommended that a contractor be hired to pump out the chamber and then apply a coating to the valve and the piping within the structure. As the chamber is pumped out, care should be taken to observe the location of any seepage, the quantity of seepage and the rate of infiltration. With this information, a judgment can be made as to the extent of any additional remedial work (beyond that noted above) which may be

required. After pumping out the chamber, the functionality of the valve should be checked. That is, the valve should be opened and closed slowly several times, first to check its operability and secondly to flush out any debris within the pipe. If the valve leaks, or the stem is difficult to turn, the bonnet may have to be opened and repacked. As the valve is flushed out, someone should be checking the discharge area to ascertain the water quality of the discharge. If it does not clear up within a short period of time, contact an engineer for advice prior to proceeding further. At a minimum, the valve and chamber should be inspected at least on an annual basis. At the same time, check for seepage into the chamber and exercise the valve as previously noted.

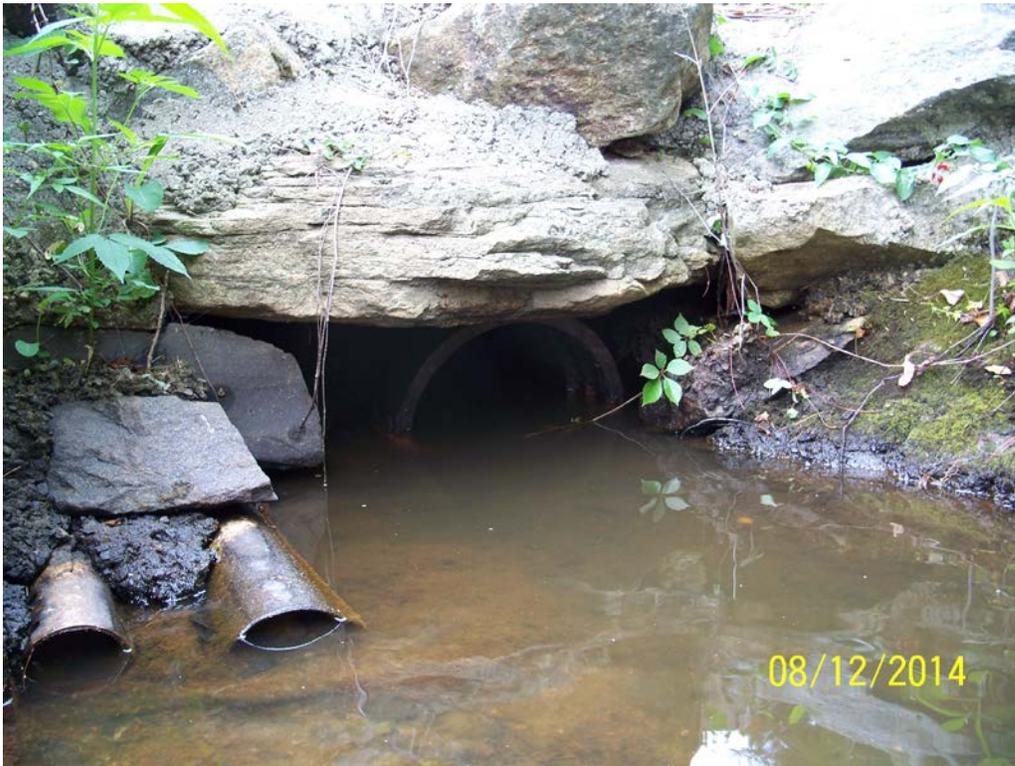
Photo 19 – The low level outlet area at the base of the left embankment adjacent to the spillway, showing the ductile iron outlet pipe and PVC discharge pipes for toe drain and spillway underdrain pipes. The intake area on the upstream side was submerged beneath pond level and could not be accessed at the time of inspection.

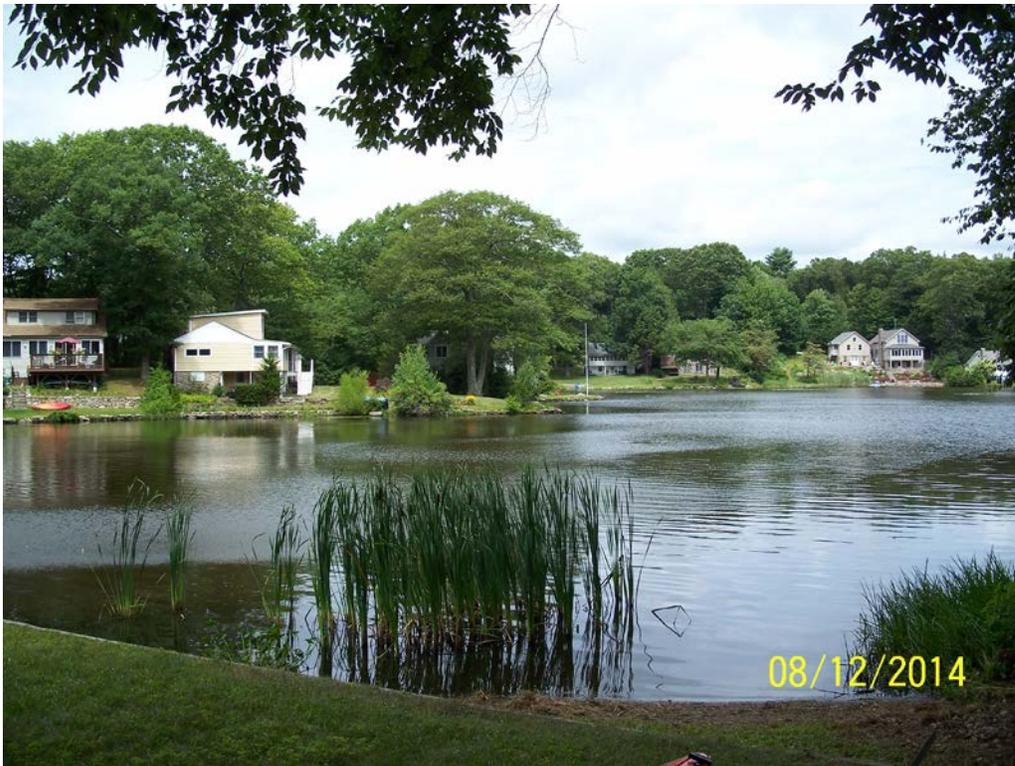
Photo 20 – An overview of Hidden Lake as seen from the left abutment of the dam.

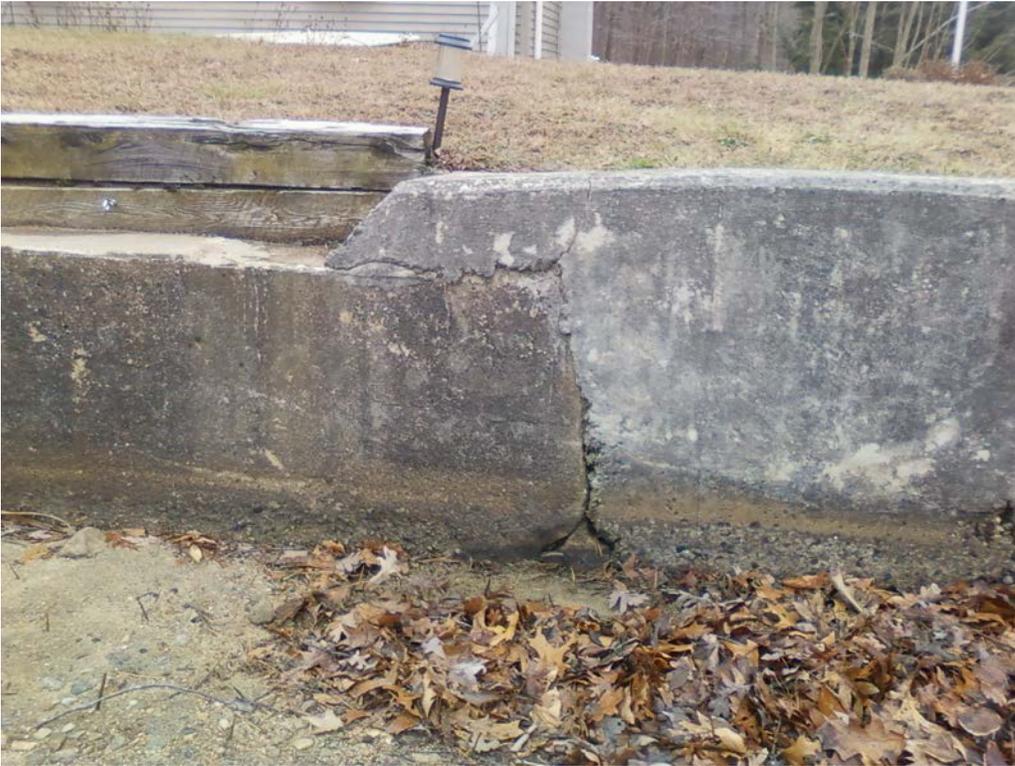
Photo 21a – The left upstream embankment wall showing minor crack and joint opening.

3. **Concrete Repairs and Maintenance** – Several minor crack and joint openings have been noted along upstream embankment walls and at their junctions with the spillway training walls. These should be repaired or maintained with the use of cementitious or epoxy repair materials and joint sealants. In addition, although a slow process, small and scattered areas of erosion on the spillway surface should be repaired and a cementitious coating should then be applied for long term protection from weathering, abrasion and cavitation.
