INSPECTION REPORT

HIDDEN LAKE DAM CT DEEP #06107

HIDDEN LAKE ROAD
TRIBUTARY TO POND MEADOW BROOK
HADDAM, CONNECTICUT

MARCH 2015

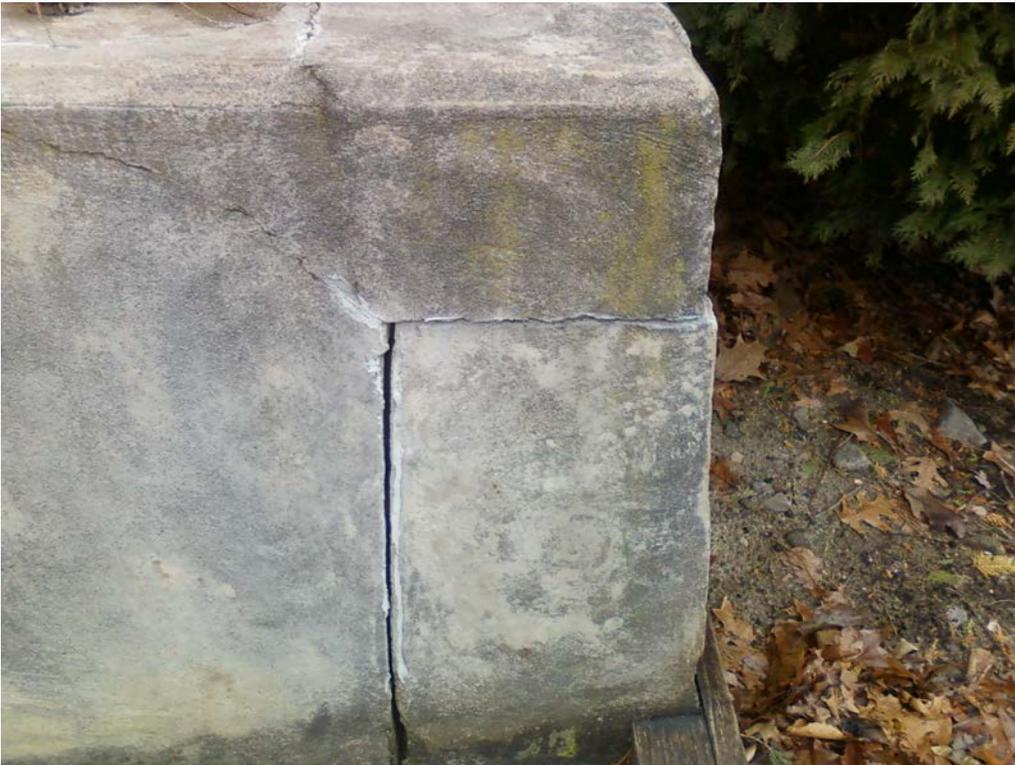
Photo 21b – Minor cracking and joint opening at the right upstream corner of the right spillway training wall. These should be cleaned and filled with appropriate repair materials.

3. **Concrete Repairs and Maintenance** – Several minor crack and joint openings have been noted along upstream embankment walls and at their junctions with the spillway training walls. These should be repaired or maintained with the use of cementitious or epoxy repair materials and joint sealants. In addition, although a slow process, small and scattered areas of erosion on the spillway surface should be repaired and a cementitious coating should then be applied for long term protection from weathering, abrasion and cavitation.

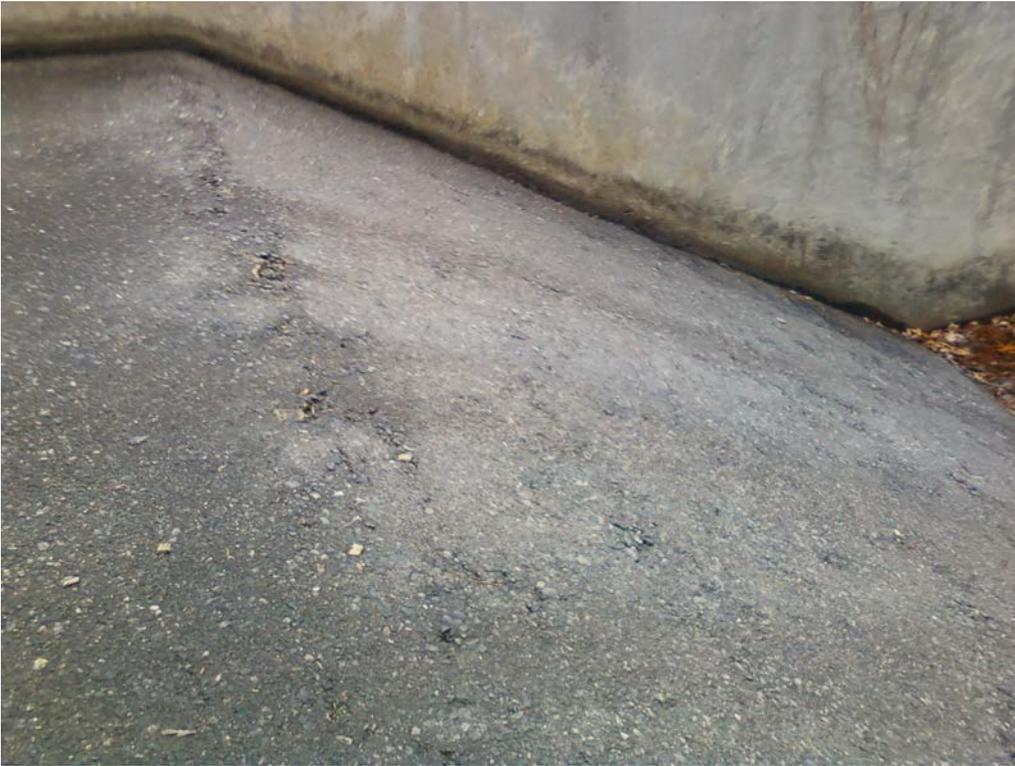
Concrete Condition: Good with minor signs of surface erosion along the spillway surface (see Recommendations).

Photo 21c – The break in the spillway weir crest showing signs of mild weathering and surface erosion.

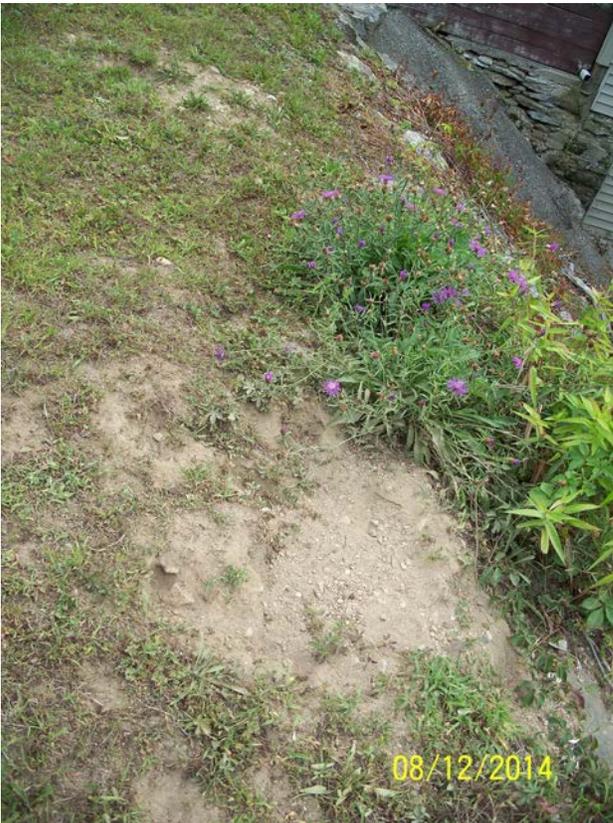
Erosion/Burrows: A small area of exposed soil was noted at the crest of the left downstream embankment between the spillway and house. This should be repaired (see Recommendations).

Photo 21d – Crest of the downstream embankment, left of the spillway and right of the house showing an area devoid of vegetation.

Grass areas on top of the dam are in good condition and well maintained. However, as pointed out in the photo report, a small area of exposed soil on the top of the left downstream slope should be repaired and then monitored until a good cover is reestablished.

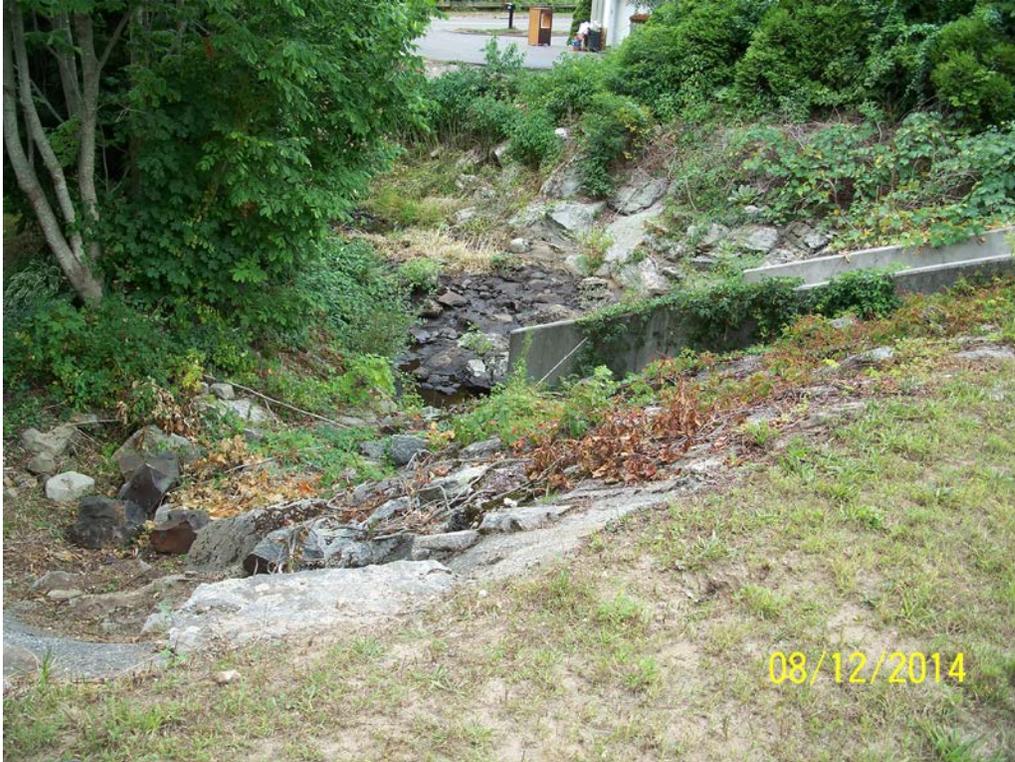
Photo 21e – An overview of the left downstream embankment, toe and channel areas, showing tree, brush and woody vegetative growth.

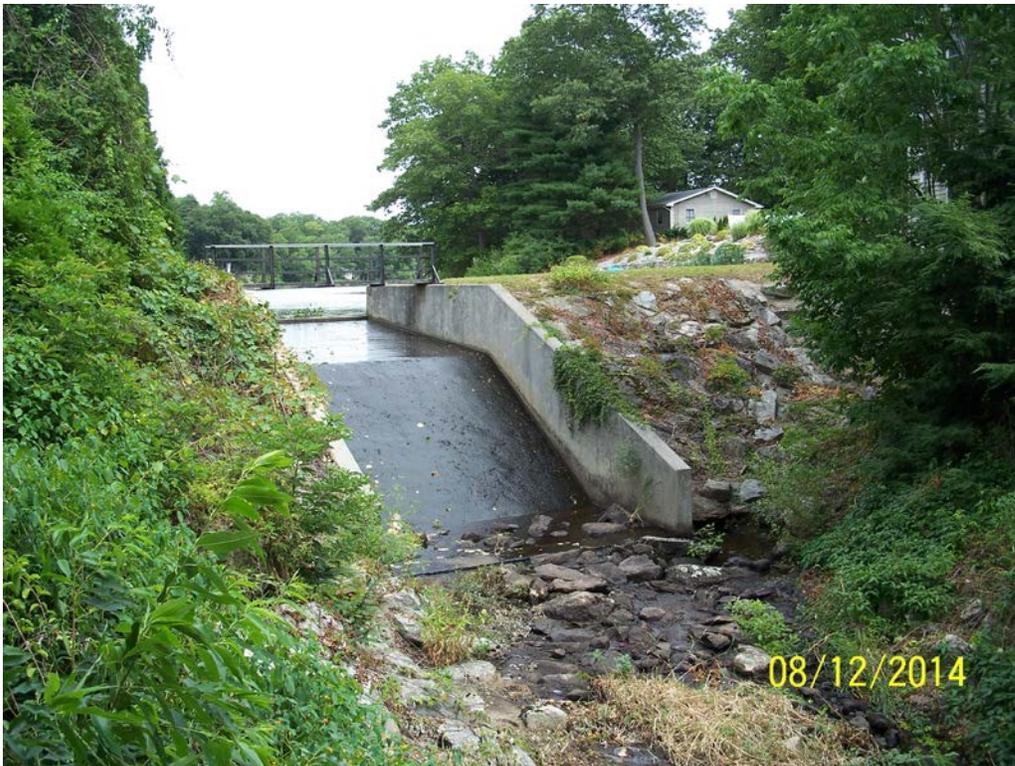
Photo 21f – Another view of the dense vegetative cover along the right and left embankment and toe areas.

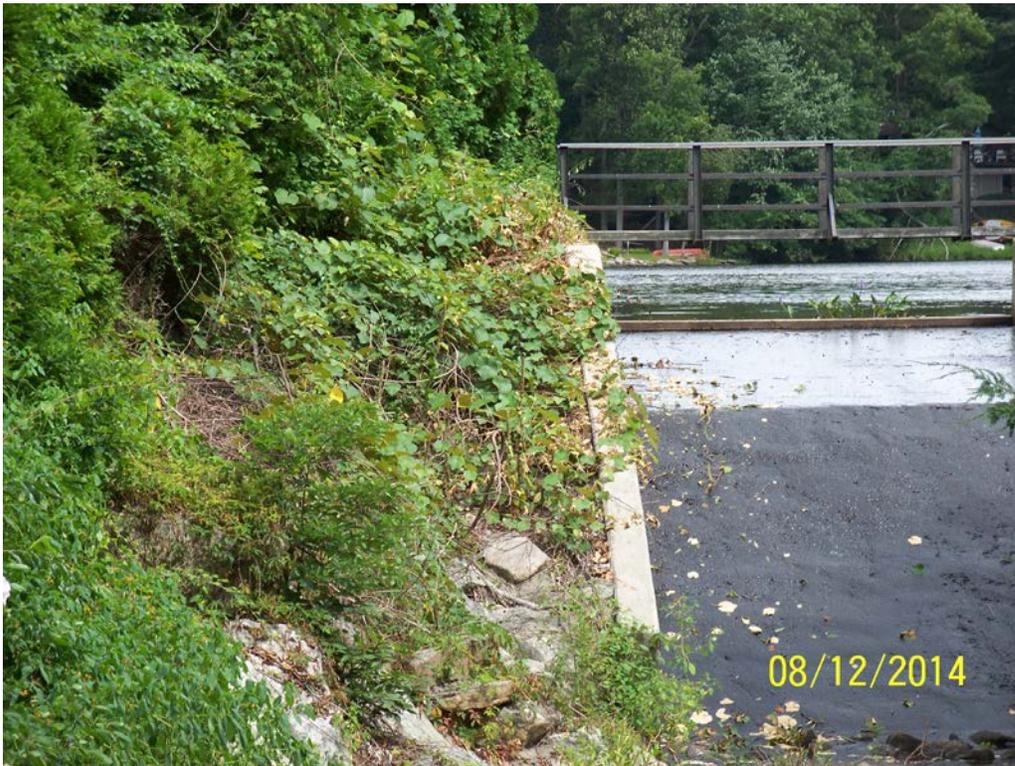
Photo 21g – The tree and brush cover along the right abutment embankment slope and dam crest.

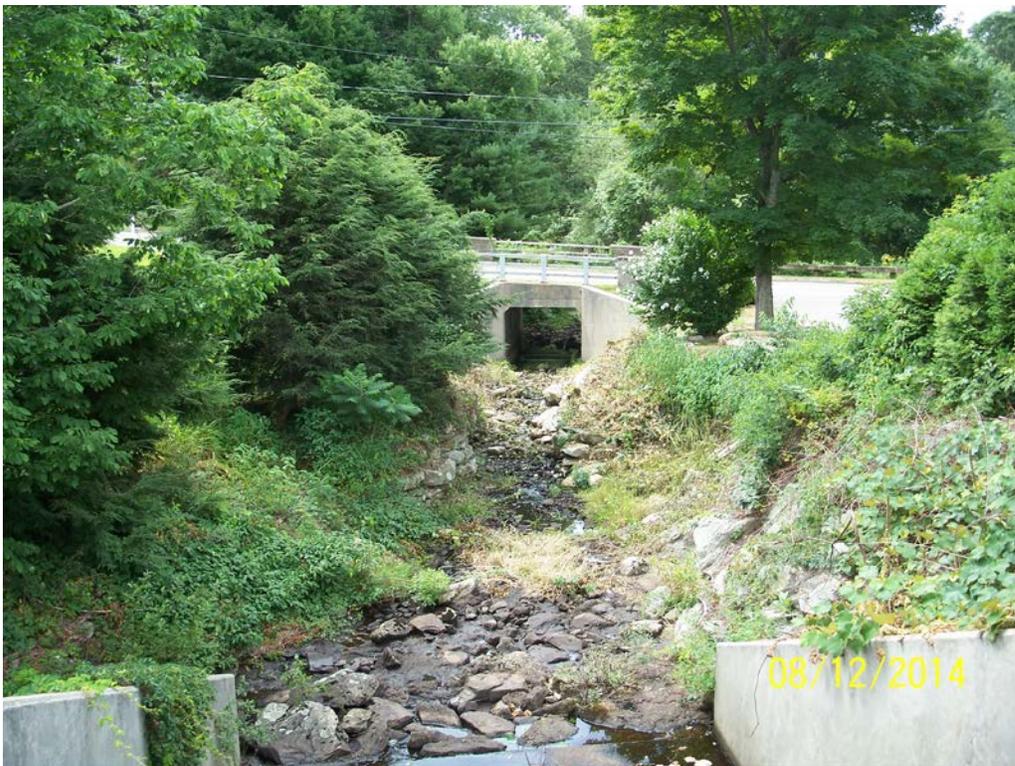
Photo 21h – The vegetative cover along the toe and downstream channel side slope areas.

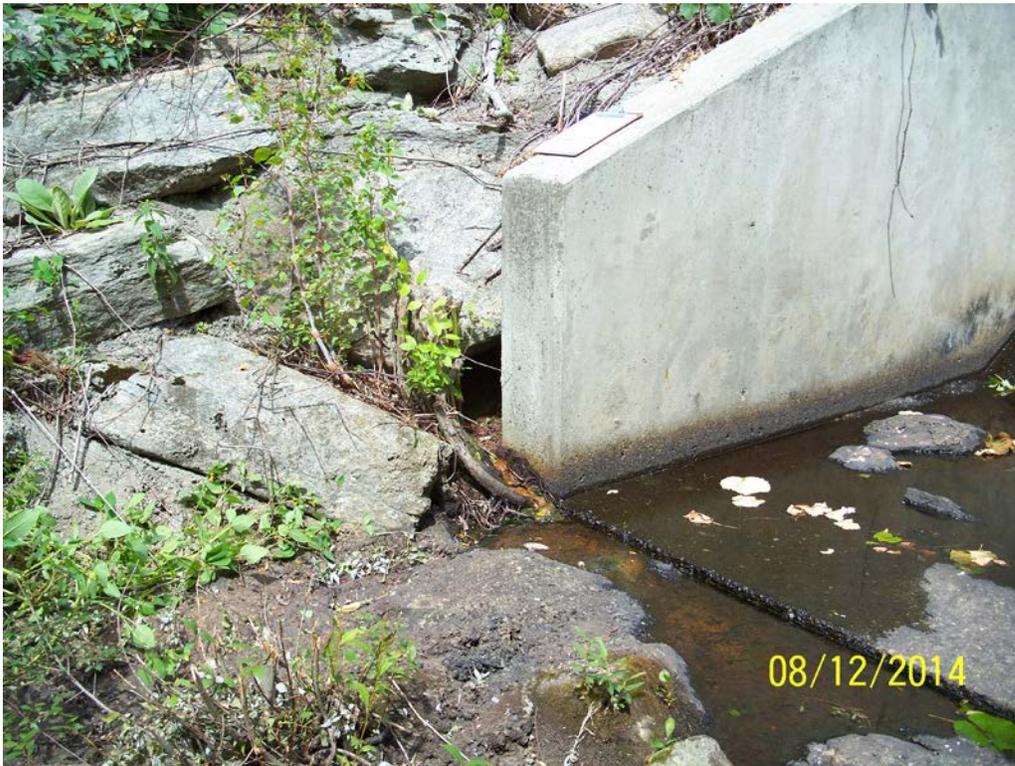
Seepage/Foundation Drainage: No uncontrolled seepage was observed. There are footing and spillway drain outlets on each side of the spillway, one of which – the right side – needs to be cleared of small roots left from cut brush.

Photo 21i – The end of the right downstream spillway training wall, at the exit of the right toe and spillway underdrain discharge. Roots in this area need to be removed to allow free discharge of flow from the drains.

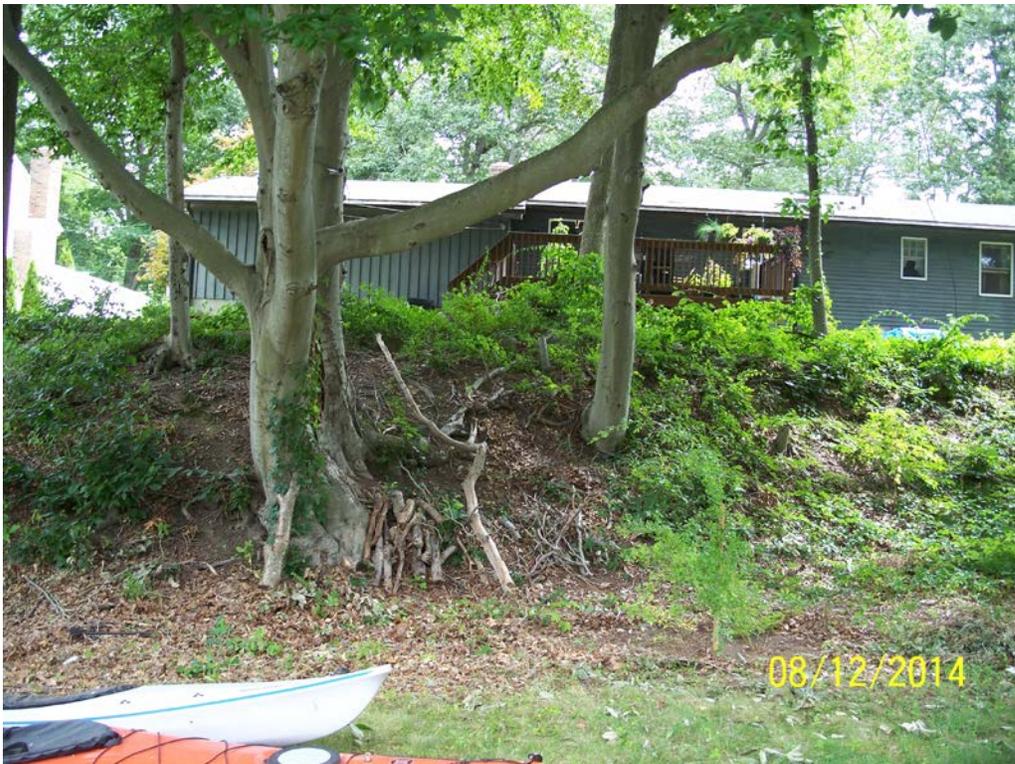
Photo 21j – Trees at the left abutment area within the 25-foot clearance zone.

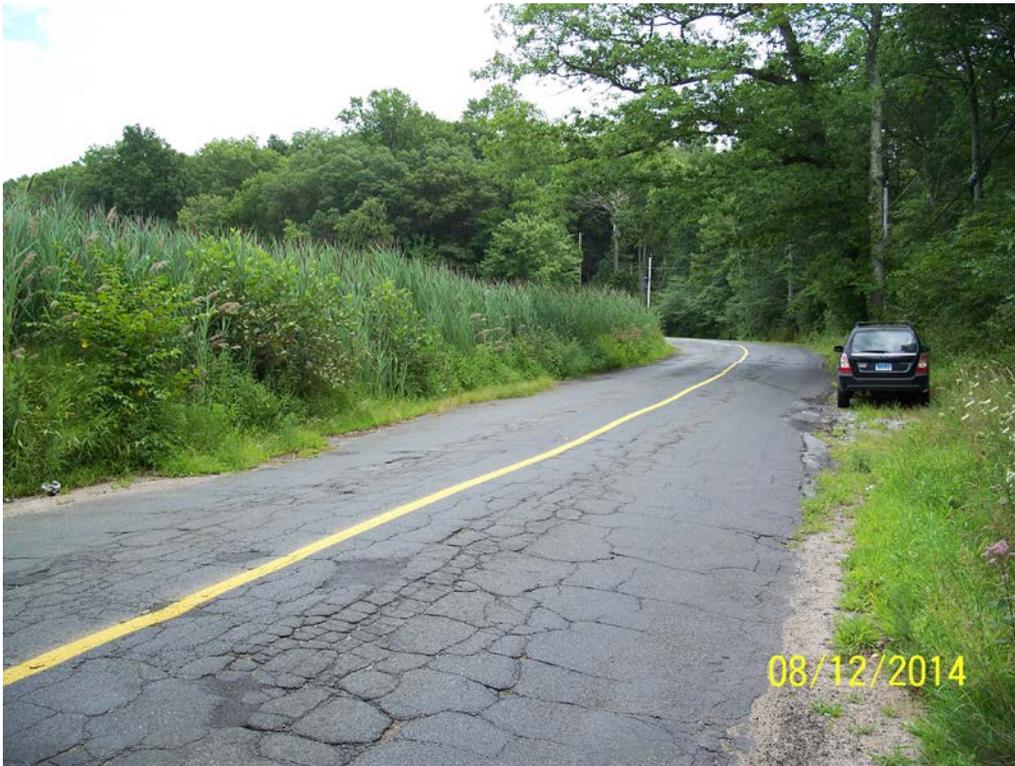
Cracks: The road surface has deteriorated and is severely cracked. Although no signs of serious issues are apparent at this time, this situation could lead to erosion during times of high overflow conditions. See Recommendations.

Vegetative Cover: The downstream side of the road embankment has a well maintained grass cover. The upstream side, however, is heavily covered by small brush, phragmites, and small emergent trees. Although this provides a substantial privacy screen for the lake, it will impede flow in the event of severe storm conditions, leading to irregular discharge points along the length of the overflow area. See Recommendations.

Photo 21k – The emergency overflow area along Hidden Lake Road, approximately 1,200 feet east of the main dam embankment, showing a heavy vegetative growth between the edge of the road and the pond, which edge is approximately 10 feet to the left of the dense growth of phragmites.
