INSPECTION REPORT

HIDDEN LAKE DAM CT DEEP #06107

HIDDEN LAKE ROAD
TRIBUTARY TO POND MEADOW BROOK
HADDAM, CONNECTICUT

MARCH 2015

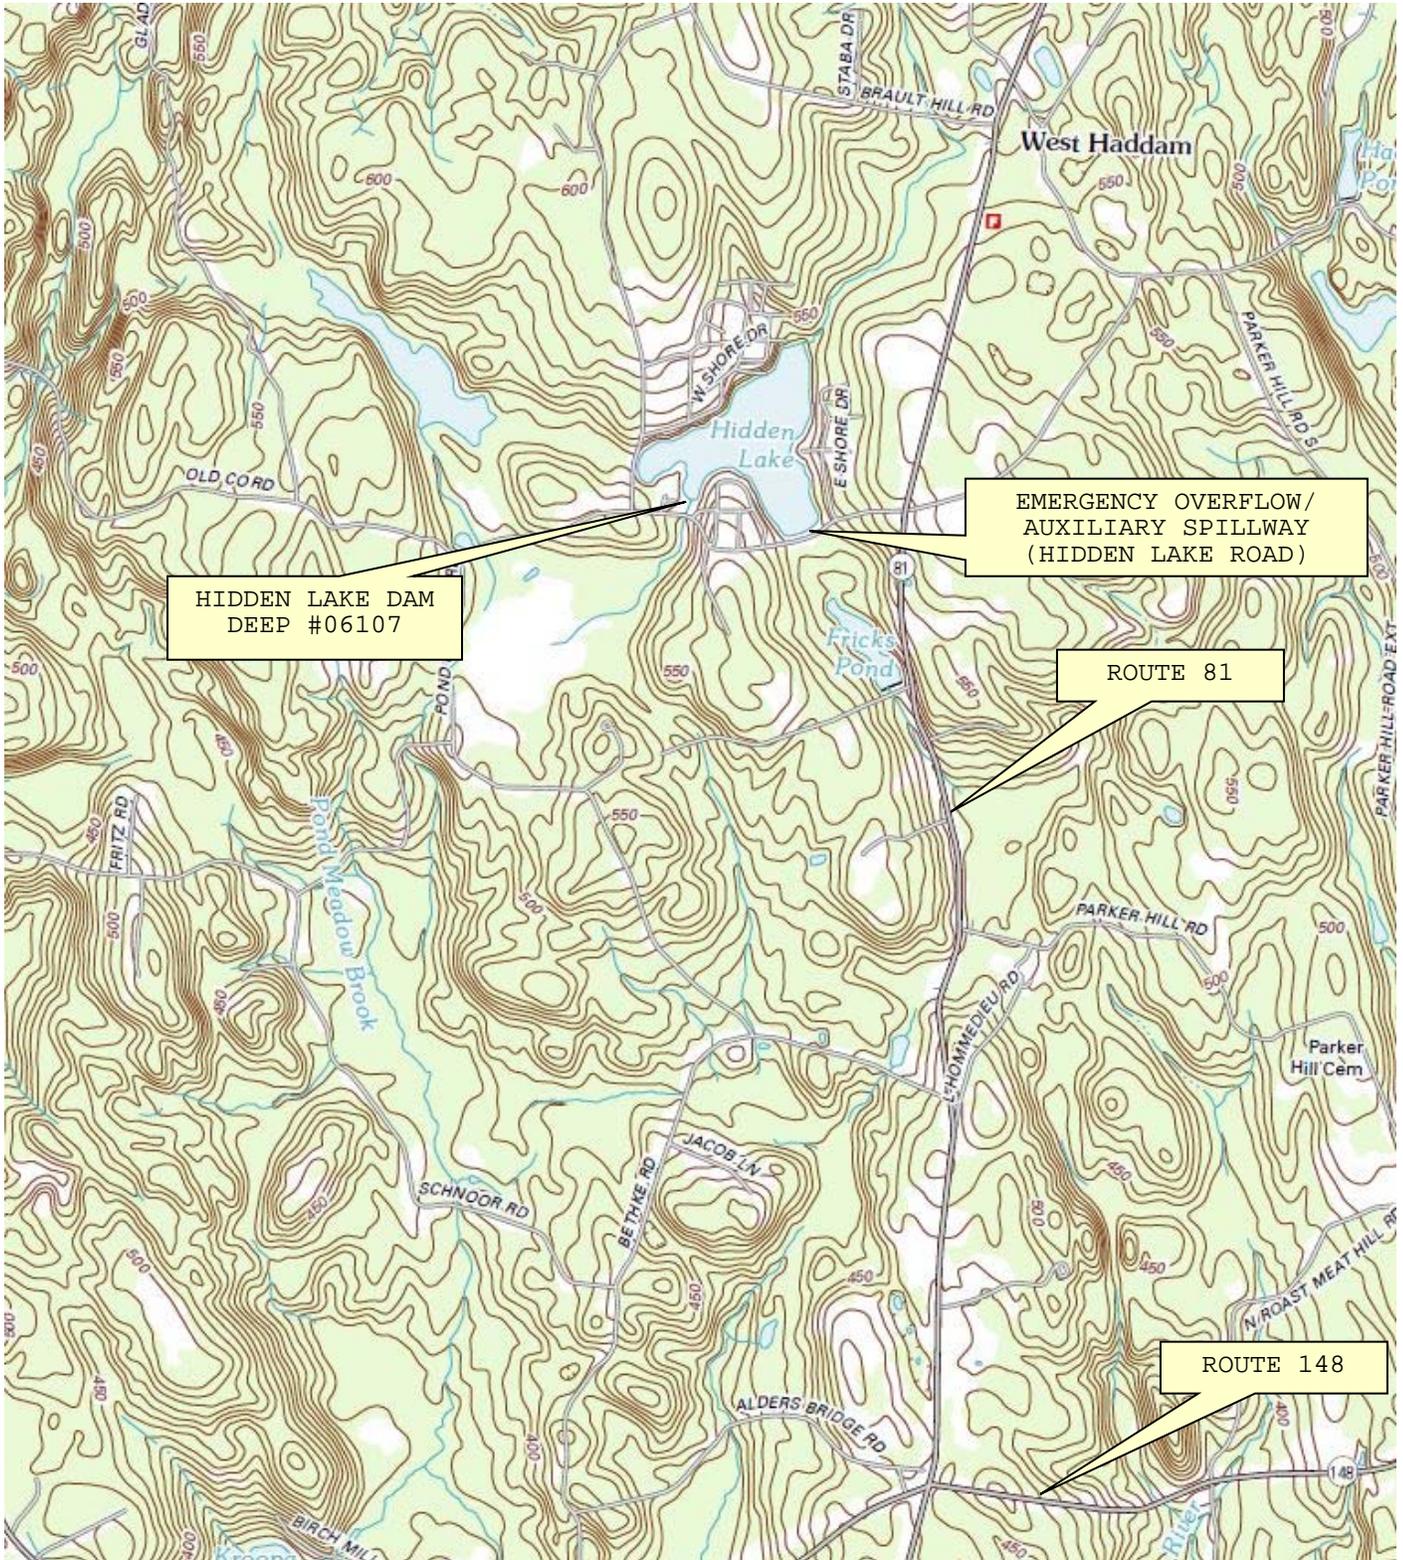
EMERGENCY OVERFLOW/
AUXILIARY SPILLWAY
(HIDDEN LAKE ROAD)

General Condition: Fair, based on road surface and vegetative cover along the shoulder areas.

Settlement/Alignment/Movement: None apparent for the area overall, but see cracks below.

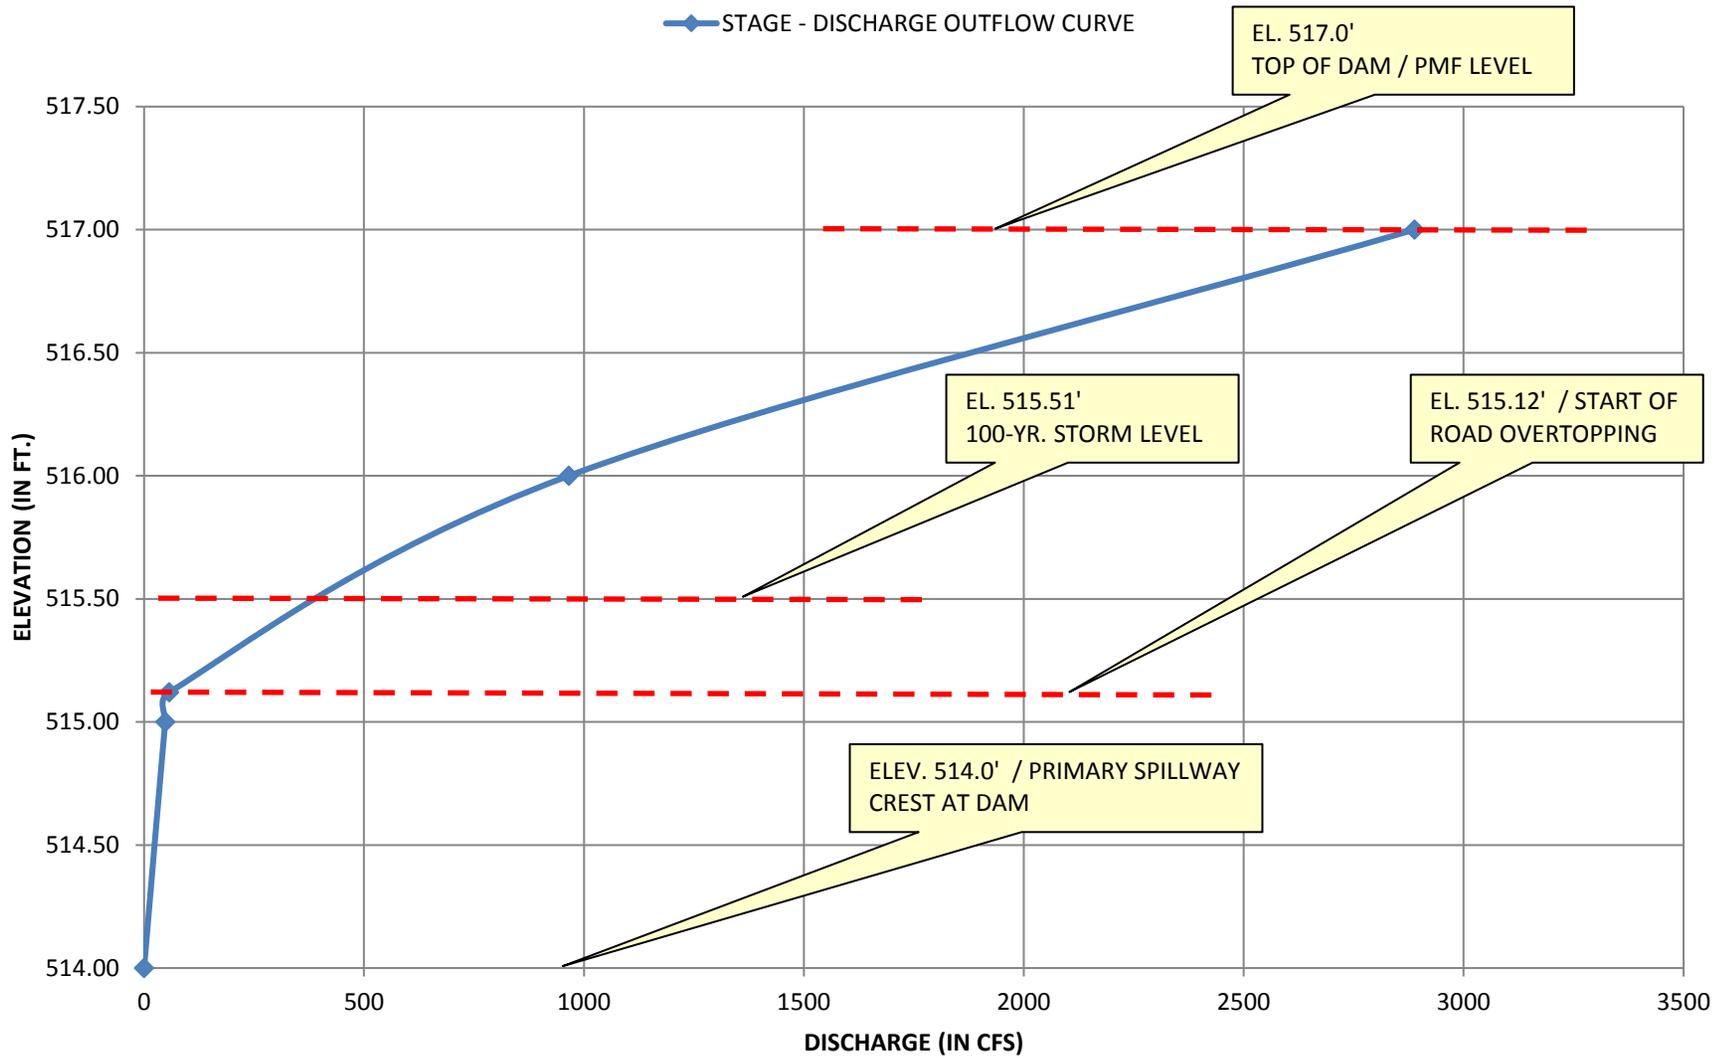
HIDDEN LAKE DAM / OUTFLOW / STAGE - DISCHARGE

An Emergency Action Plan was recently submitted to the DEEP for review; it takes into account the latest reconstruction and the potential overflow area to the east of the dam. As part of the preparation for this submittal, a hydrologic and hydraulic analysis was performed. The results of this analysis indicate that the 100-year storm safely passes the spillway with approximately 1.9 feet of remaining freeboard, but overtopping the road to the east (emergency overflow area) by about 0.4 feet. In addition, the PMF outflow reaches just to the top of the dam without overtopping, but with the road to the east being overtopped by about 1.9 feet. (See attached Outflow Stage Discharge Curve.)
